Rapid Visual Screening of Buildings for Potential Seismic Hazards: A Case Study of Chiplun City

Abstract:- The objective of this study is to assess the seismic vulnerability of R.C.C. and load bearing structure of the Chiplun City area by R.V.S (Rapid Visual Screening) method for Indian condition. The RVS method is a preliminary survey conducted to check the seismic vulnerability of existing structures in a systematic way. The method consists of the steps as, visual inspection followed by detailed investigation and finding a score which decides the need of detail seismic structural analysis. An attempt has been made to do rapid visual screening of RCC building and Load bearing building which available in Chiplun. RVS score has calculated for 40 buildings and plotted normal distribution Graph for each building to understand the distribution of RVS score of buildings in Chiplun. From the study, Results of the performance scores more than 2 around 57% (23 out of 40) of buildings are reinforced concrete as well as Load bearing structure also, Results of the performance scores more less than 2 around 43% (17 out of 40) of buildings are reinforced concrete as well as Load bearing struct

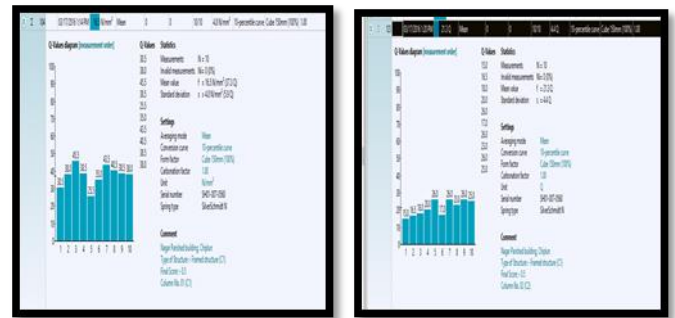
Fig 4 Rebound hammer test on Municipal building

Archies	-10	-10	-10	-10	Present=+1, Absent/Do not know=0		0
Diaphragm Action	10	10	10	10	Present/Do not know=0, Absent=-1		0
Rebound Rattle Stone Masonry	-15	-15	-15	-15	Present=+1, Absent = 0		-15
Year of construction	-5	-10	-10	-15	Does not exist=0, >50 year = -1, <50 year = +1		-10
(Source: Sudhir K. Jain and Keya Mitra 2008)							
Performance score $1.6 < 2$							80
Detail evaluation required.

The said structure is RCC structure. There are two buildings attached together one is old load bearing structure and another is RCC structure which is connected to the old building. The old structure is constructed in year 1942, whereas RCC structure constructed in year 2002. The condition of the old structure is better than new structure which observes in figure 3. In new building observe plan and vertical irregularities which make structure instable for earthquake. The condition of the roofing is quite bad. Many of the sheets are breaks. In the building observe deflection in beam, cracks in wall as well as in plaster. Condition of Door and window are not good. The rebound hammer strengths of some beams are considerably low and may be liable toward the failure. The slab is also undergoing large amount of deflections at various location in overall structure. The cracks are also developed in the various columns of the structure. The bulking of columns are also observed during the survey. As per the rebound hammer results for various column sections, it is also observed that the strength of some columns are reducing considerably. The said structure does not seem to be suitable for any use. The performance score is less than 2, so building required detailed investigations.

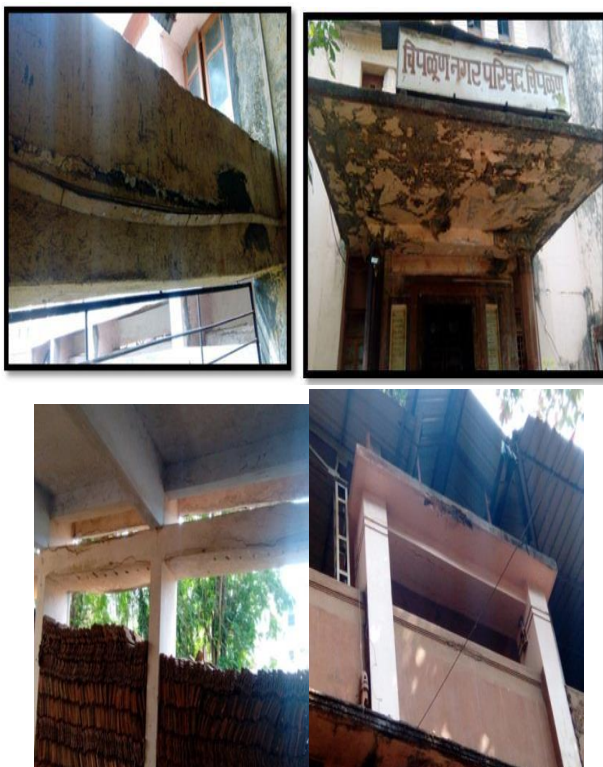
Fig 5 Internal structural condition of Om Prakash Malu Building

This is the old load bearing of composite steel and wooden structure. The structure is constructed in year of 1901. This structure located at main market area. The constructed area of the building is more about 1500 to 1600 sqfeet. Today this structure is used for the shop only not for residence. The building having pounding effect as well as not in good condition. The structure having G + 1 structure. Ground floor is almost used in shop but first floor condition is bad and required maintains, which shown in the fig 5. The RVS score is less than two, so required detailed evaluation.

COMMENT		Performance score
Performance score - 1.46 < 2		73
Detail evaluation is required.
