Major Repairs & Renovation Work of Co-operative Housing Society Building

Vivek Singh¹, Pallavi Bharadwaj², Natraj Patil³

Our Projects Name Diamond Court C.H.S. Ltd. Is located at Andheri (E), Maharashtra. The building is a R.C.C. frame structure having Ground + 5 storeys. Fieldwork started from 14th March, 2017 and the entire survey work was completed by 16th March, 2017. Preliminary drawing preparation, Visual inspection and tapping was carried out simultaneously; results of the same are presented in this document. Non Destructive Tests such as Ultrasonic-pulse velocity test, Carbonation depth measurement, Rebound hammer test, Chemical Test, Core Cutting Test, Half-cell potentiometer test, Cover meter test etc. were carried out.

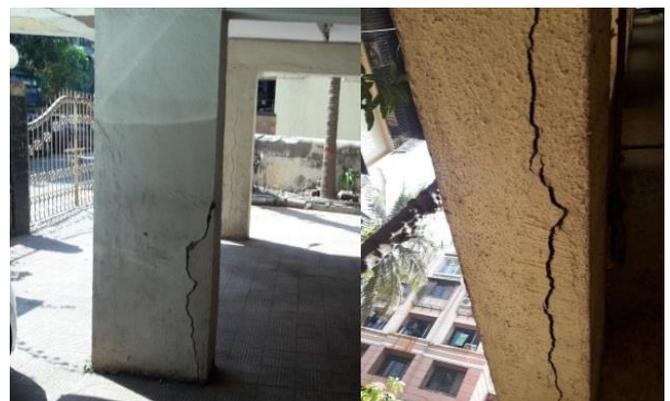
The external face of the building shows cracks in external plaster at certain locations, vegetation growth was observed at external face as well as plumbing joints at few locations. Major structural cracks were found at many locations including beams and columns during the survey/inspection work. Plumbing and sanitation lines at external walls of the building are in moderate condition. Leakage marks are found at the pipe joints of the plumbing lines at few places externally. Refer exhibits for more details.

Some of External cracks

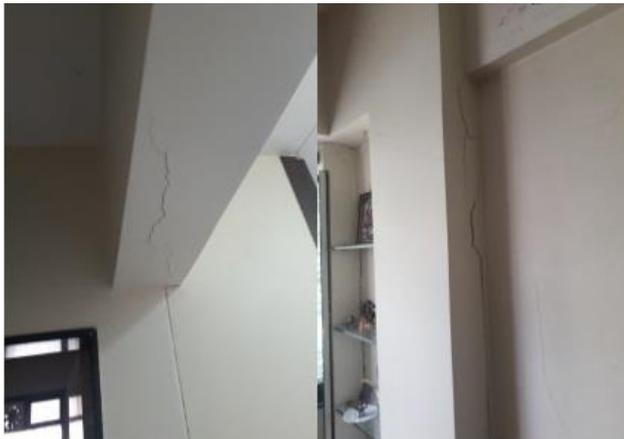
Leakage & seepage marks are observed inside the flats due to internal wall to wall leakages with damaged external plaster & formed cracks. Cracks in ceiling was observed at many location. Major structural cracks is observed in R.C.C. load bearing members. Uneven flooring tiles were observed at many places inside flats.

Some of Internal cracks

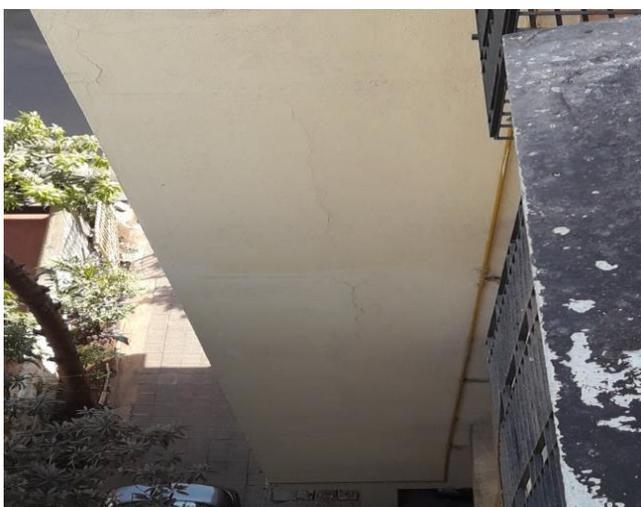
The observations are based on visual survey and non-destructive Test conducted by our team of Engineers. An extensive investigation to collect full details and scope if repairs has been carried out. Observations are prepared in this effect, and the same are attached with this report. The R.C.C. members are in a distressed condition.

Some of External cracks

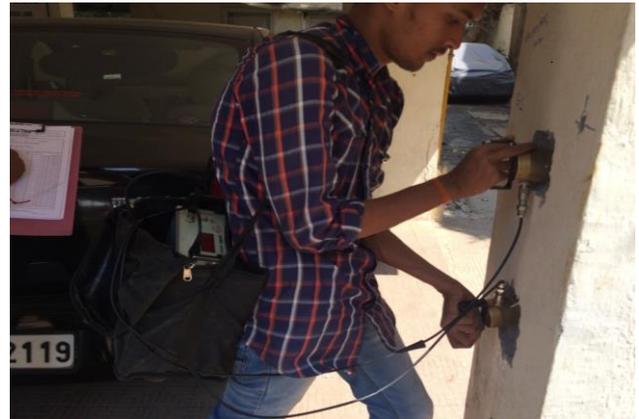
Ultra Sonic Pulse velocity test

The readings in this case are in range of 1.62 Km/sec to 1.92 Km/sec and the average reading is 1.71 Km/sec, which indicates concrete quality to be doubtful.

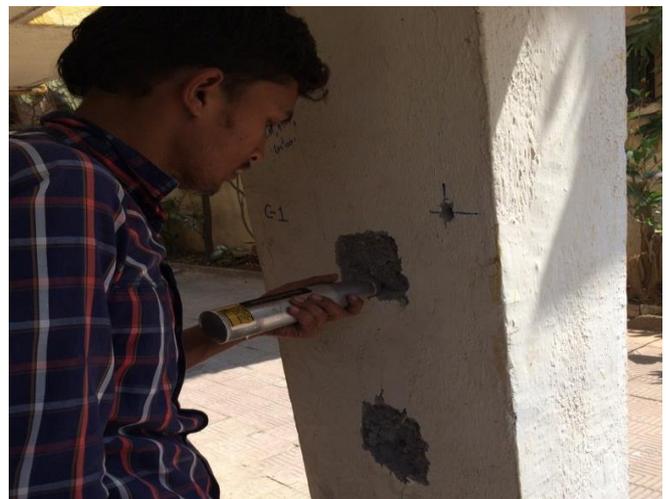
Rebound hammer test

The rebound number in this case are in range of 22.4 to 24.2, average reading is 23.16 & average Equiv. Cube strength is 11.88 N/mm², which indicates poor compressive strength.

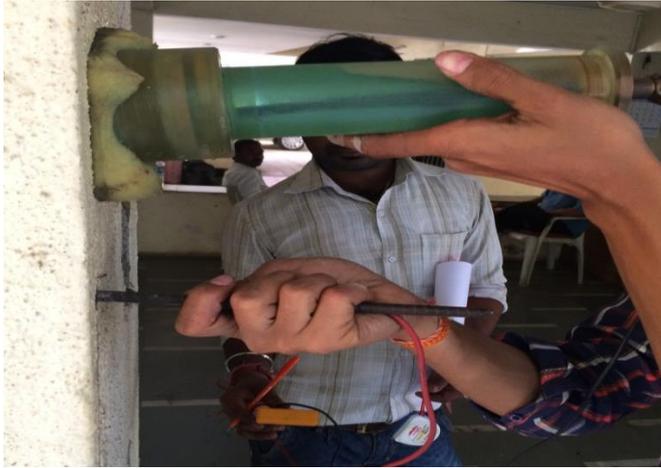
Half Cell Potential

The readings lies between -272 mV to -291 mV which indicates that an increasing probability of corrosion.

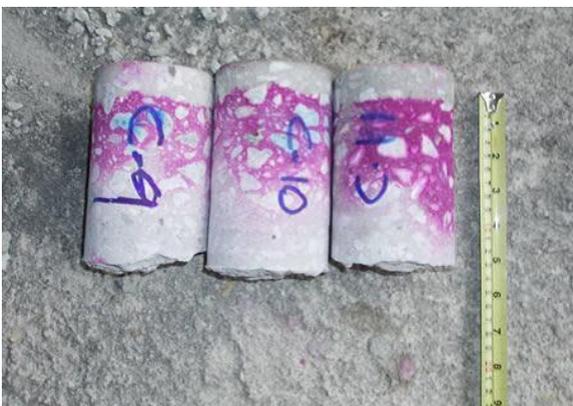
Carbonation

Depth of carbonation in R.C.C. members are in range of 45 mm to 50 mm and average depth of carbonation is 47.5 mm, which indicates 86% carbonation of concrete.

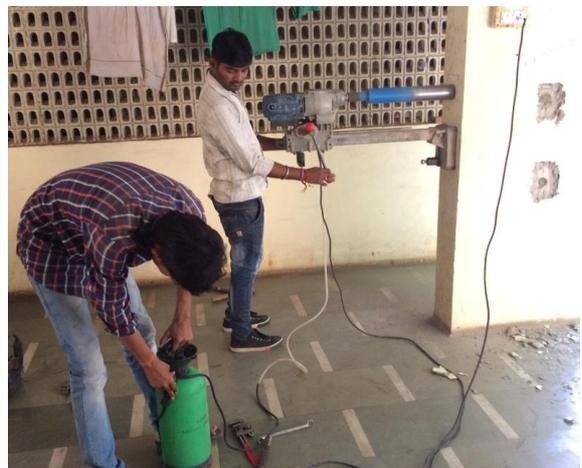
Concrete Core Test

The equivalent cube strength of concrete is 11.9 N/mm² which is poor.

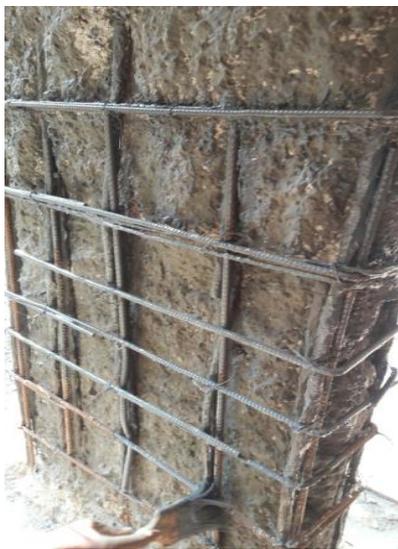
Anti-rust chemical application

Brushing with wire brush and removing all rust scales from rebars & washing with water as required and providing and applying Rust Remover on existing exposed reinforcement bars

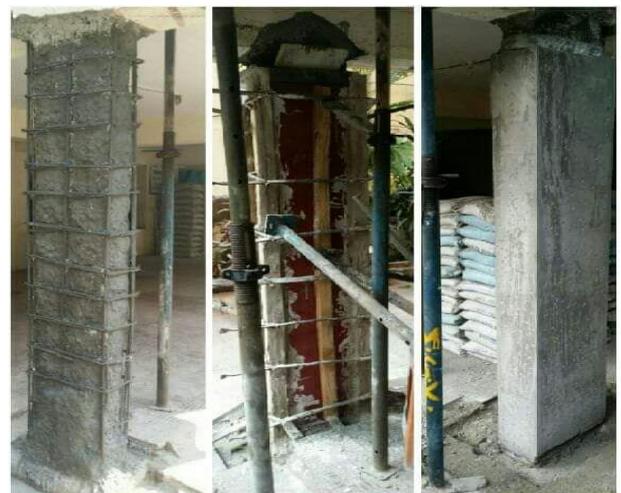
BREAKING SHUTTERING MICRO CONCRETE

Providing and laying Super Fluid Micro concrete which shall be single component, non-shrink, free flow, self-compacting, ready to use after mixing water in specified proportion to the beam bottoms, columns, slabs, etc. with shuttering, pouring, tamping, Consolidating, curing etc. Complete as per the direction of Consulting Engineer / in-charge.
