# Strength Evaluation of Damaged Structures – A Case Study of Fire Damaged Building.

This paper discussed on the case study of a fire damaged building. The building is RCC framed Ground + Two upper floors. The building is constructed 50 years ago. Due to the fire raw material like carbon powder and rubber is burnt. The machine mounted on first floor is damaged. Aluminium partition and M.S grill of windows is broken and damaged due to fire. Effect of the fire to the structural components can be seen from the shaded colour of wall, columns and beams, at all over the surfaces. The structural assessment was aimed to investigate effect of fire to the elements inside the building, to investigate the condition of the main structural element due to the fire and to recommend overall condition of the building.

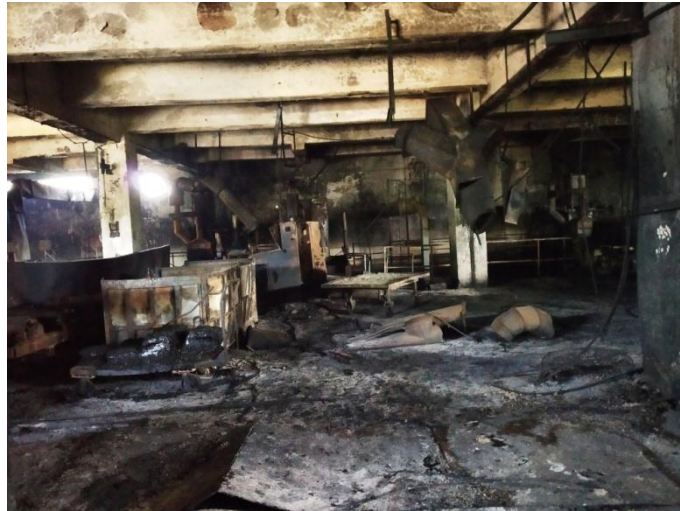
On the first floor, reclaimed rubber, machine oil, FRP pallets and drums were kept, Rubber is burnt partially and pallets are melted partially. Remains of MS frame of oil drums neither bent nor melted. RC beam and slab in the grid B26-B27, D28-D29 were affected by fire and heat. Spalling of concrete cover is observed. Reinforcement is exposed in certain members. Inspection of mild steel reinforcement in RC members doesn't show any debond condition. No powdered steel existence is observed. Freshly broken concrete shows grey colour. Plaster of all members is completely damaged on the first floor plaster surface shows crazing and cracking.

**Figure 1: Interior view of first floor of damaged building**

RC members affected externally only. There is no appearance of severe damage for RC members except spalling of plaster and cover concrete at certain parts of beam and slab. The concrete to steel bond was determined to be good. The building is constructed 30 years ago. The grade of concrete used is M15 and mild steel reinforcement cover to concrete members is good. As grade of concrete is M15, section size of members is large, which might be beneficial, in case of fire incidents. It is recommended to do the surface repair of slab and beam.

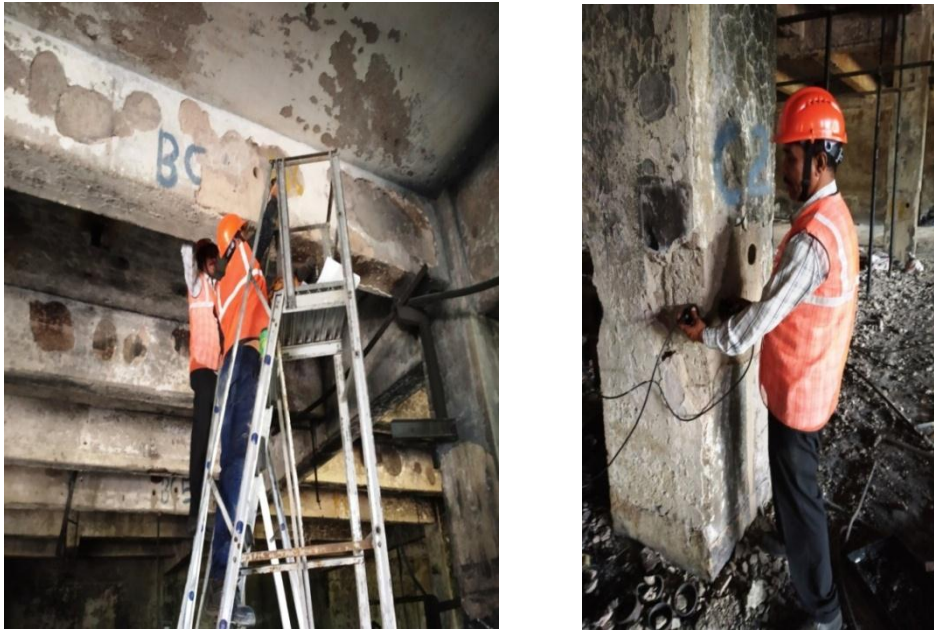
UPV test is taken on core samples taken from fire exposed area and unexposed area. UPV test is conducted at different length of core starting from fire exposed site. The UPV test is also conducted on in-situ structural member beam, column and slab. The test conducted in all members is nearly same. The average UPV test 3.16KM/Sec showing medium quality rating of the concrete.

**Figure 2: USPV test on column and Beam**

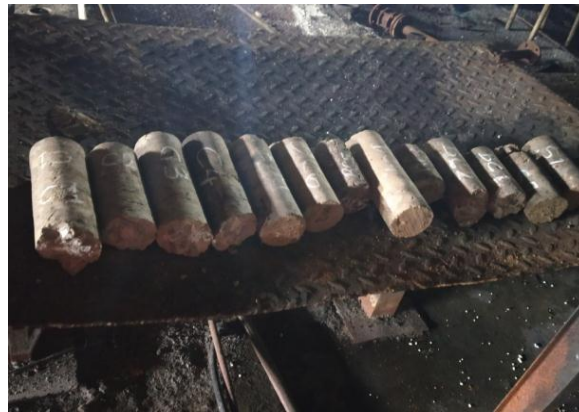
The core samples are tested for compressive test of existing concrete also. The core samples are tested in laboratory. The samples give the average compressive strength 14.89 MPa.

**Figure 3: Core collected at site**
