PARTIAL REPLACEMENT OF BROKEN ROOF TILES AND BONE WASTE IN CEMENT CONCRETE

Abstract - This study has been undertaken to investigate the determine the performance of concrete with partial replacement of coarse aggregate with broken roof tiles and fine aggregate with bone waste. The broken roof tiles waste was varied from 0% to 50% for coarse aggregate and bone waste was constant at 4% for fine aggregate in M20 mix. Split tensile strength test was conducted to determine the strength of beam. As per the result analysis the maximum strength was obtained at 30% of partial replacement. This project ensures an eco-friendly and cost-efficient nature of the proposed replacement, aiming to sustainable construction practices.

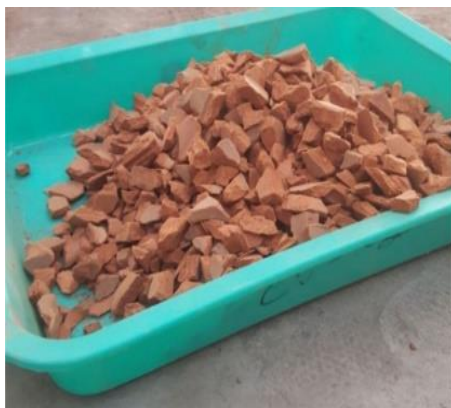
Fig1. Broken roof tile

The roof tile we used, is manufactured from Malabar supreme roof tile company shown in figure 1. The physical and chemical properties of broken roof tiles is given in table 4.

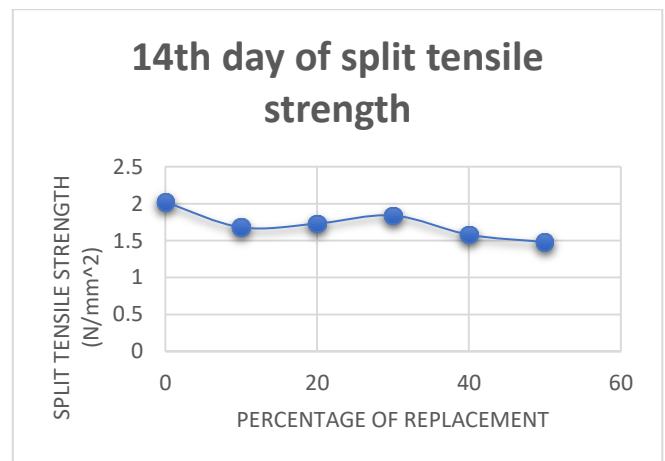
The split tensile strength of different mixes for 7,14 and 28 days are shown in Table - 7. Conventional concrete and different mixes of partial replacement of coarse and fine aggregate with broken roof tiles and bone waste in concrete. Tensile strength results are compared by plotting graphs shown

1. Split tensile strength of concrete made using broken roof tile as partial replacement for coarse aggregate at 30% and 4% of natural sand is replaced by bone aggregate

replacement level is comparable to that of ordinary concrete both at 7,14 and 28 days.
