# Six Sigma Report: Boeing 787 Dreamliner Battery Issue Analysis and Improvement

**Abstract** - The Boeing 787 Dreamliner faced critical operational challenges shortly after its launch due to issues with its lithium-ion battery system, leading to fleet groundings and significant financial losses. This report applies the Six Sigma methodology to analyze and resolve these battery-related problems. The analysis focused on two major battery fire incidents that grounded about 50 aircraft globally. Six Sigma tools, such as Pareto charts, Fishbone diagrams, and histograms, were utilized to identify the root causes—thermal runaway and short circuits—which accounted for 90% of the failures.

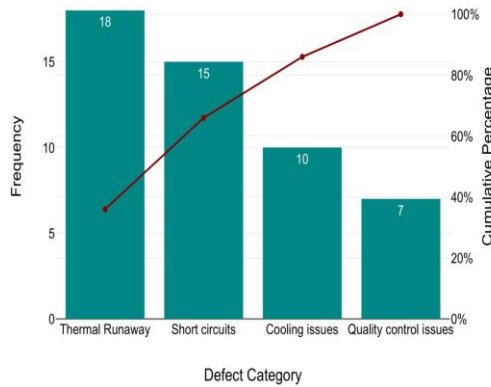
Chart -1: Pareto chart

It illustrates the distribution of defects by category, highlighting the most significant problems contributing to battery failures.

\* X-Axis: Categories of Defects (e.g., Thermal Runaway, Short Circuits, Cooling Issues, Quality Control Issues)

\* Y-Axis: Number of Incidents

\* Cumulative Percentage Line: Shows the cumulative impact of each defect category.

Defect Category	Number of Incidents	Cumulative Percentage
Thermal Runaway	18	40%
Short Circuits	15	70%
Cooling Issues	10	85%
Quality Control Issues	7	100%

Based on the figure we can see the order of defects from the largest to the smallest. The largest defect is the thermal runaway which has a 40% defect percentage. It needs to be considered for regular thermal management and maintenance.

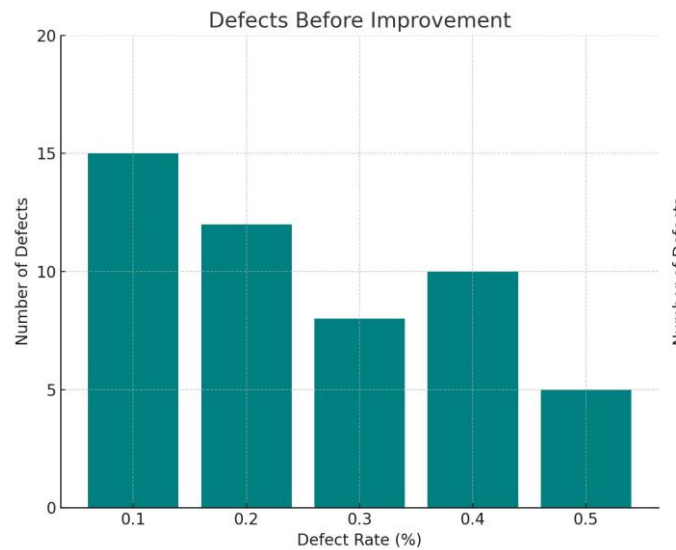
Chart -2 Histogram before improvement

\* X-Axis: Defect Rate (%)

\* Y-Axis: Frequency of Occurrence

Before Improvement:	
Defect Rate (%)	Frequency
0.5%	5
0.4%	10
0.3%	8
0.2%	12
0.1%	15

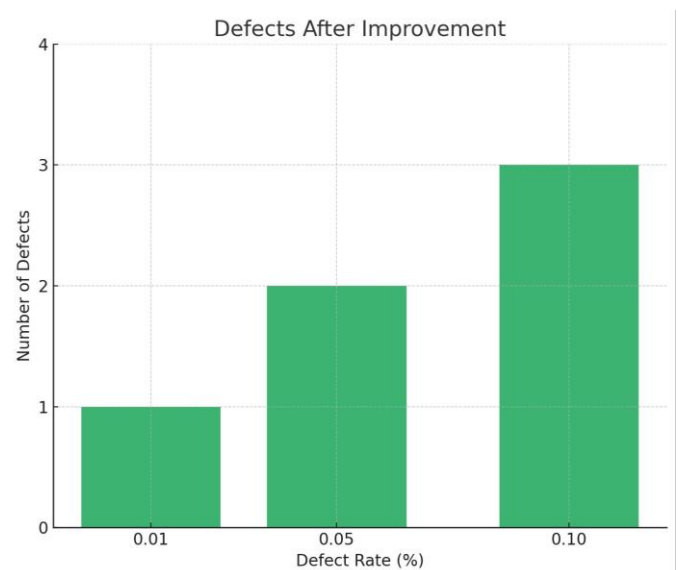
Chart -3: Histogram after improvement

Defect Rate (%)	Frequency
0.1%	3
0.05%	2
0.01%	1

(We have substantially reduced the defect percentage of the batteries by following quality control methods.)

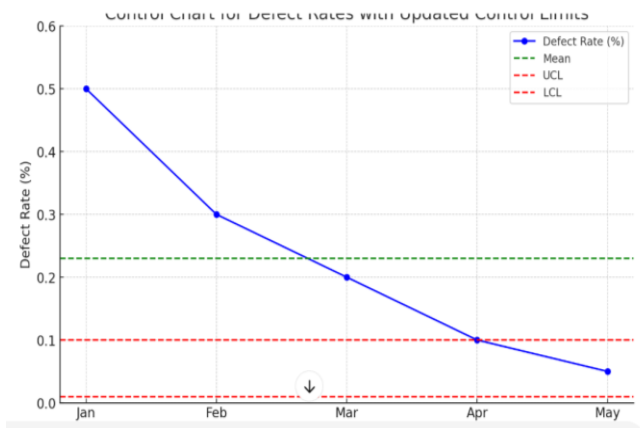
**Chart -4: Control Chart**

\***UCL (Upper Control Limit): 0.1%** (red dashed line at 0.1%)

\***LCL (Lower Control Limit): 0.01%** (red dashed line at 0.01%)

\* **Mean Defect Rate:** Green dashed line showing the average defect rate

1. **Defect Rate Trend:** The defect rate is steadily decreasing from January to May, which indicates an overall improvement in the process quality over time.

2. **Control Limits:**
  - The **UCL (0.1%)** and **LCL (0.01%)** represent the boundaries within which the process is expected to operate if it is under statistical control.

- All data points, except for April and May, are above the UCL, indicating that the process was not in control for those months as the defect rates were significantly higher than the UCL.

3. **Process Stability:**
  - Since the defect rates for most months (January through March) are far above the UCL, it suggests that the process was unstable and not capable of consistently meeting the control limits during that period.

- In April and May, the defect rates fall within the control limits, suggesting that the process may have become more stable and in control during these months. However, April's rate is right at the UCL, suggesting it's still borderline.

4. **Process Improvement:**
  - The continuous downward trend in the defect rate suggests that improvements are being made, which are bringing the process closer to being within control. The

substantial drop from January's 0.5% to May's 0.05% indicates effective corrective actions were taken.

Summarizing the control chart it is shown that after April month the range is stable that is we have achieved our desired goal.

- a. If the goal is to consistently keep the process within control limits, further improvements are needed, especially to maintain the defect rates within the desired range (below the UCL).
- b. Investigation into why the rates were high in the earlier months should be conducted to prevent recurrence.
