REPAIR OF DAMAGED REINFORCED CONCRETE BEAM EXTERNALLY BONDED WITH GFRP PLATES

Sarita R. Khot¹ H.S.Jadhav²

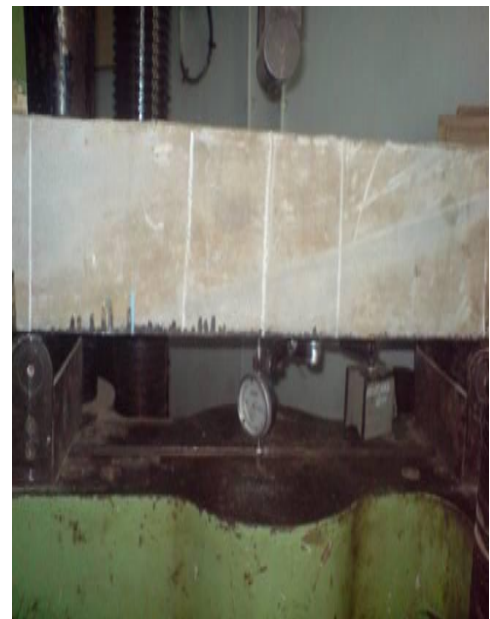
Fig.3 Beams test set up

All the beams were tested under simply supported condition. The testing was done under two point loading using the Universal Testing Machine of 600 kN capacity. Each beam was instrumented with dial gauge to observe the midspan deflection. The deflections were recorded for each incremental load of 5 kN. All the beams were tested up to the failure of beam in a single load cycle. The crack pattern was observed during the testing. The beam testing set up is shown in Fig. 2 and 3

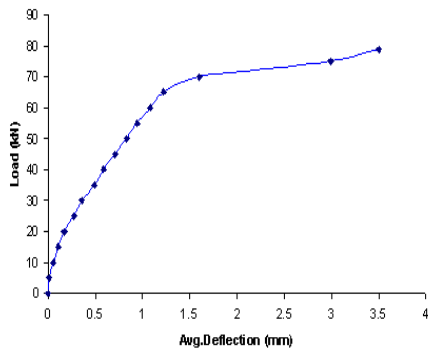
Fig.4 Load Vs Avg. deflection curve for reference beams (RB)

Identification	Ultimate load (kN)	Deformation at yield (Δy) mm	Average Deformation mm
RB1	78.50	1.30	3.5
RB2	78.50	1.14

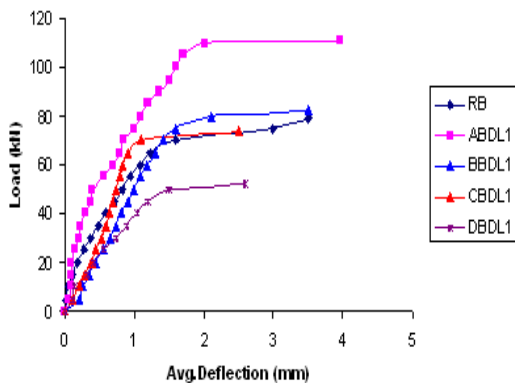
Fig.10 Load Vs Avg. deflection curve for the beams for damage degree in double layer with 100 mm width.

Identification	Ultimate load (kN)	Deformation at yield (Δy) mm	Average Deformation mm
RB	78.50	1.30	3.5
ABDL1	111	1.1	3.96
BBDL1	82	1	3.5
CBDL1	74	1.1	3.5
DBDL1	52	1.04	2.6

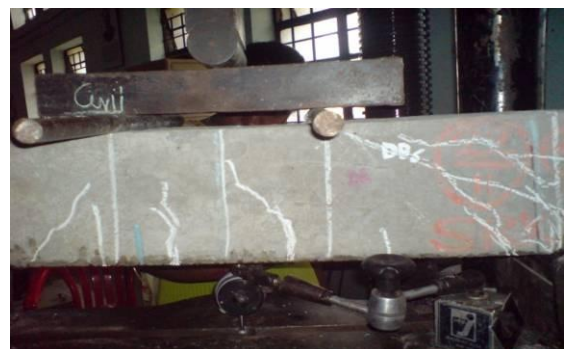
Fig.11 Shear and flexural cracks

Normally four flexural failure modes were observed with GFRP plate externally bonded reinforced concrete beams. These failure modes occur after considerable flexural cracking and development of yielding steel reinforce bars. The width of GFRP plate and improper surface preparation affect on the failure mode of the damaged strengthened beams. The reference beams (RB) failed by crushing of concrete at top of beam after yielding of steel bar and occurrence of many flexural cracks on the tension face of the beam.
