# STRUCTURAL AUDIT OF RCC BUILDING

### NAME: JUNTA QUARTERS

- LOCATION: GOA,MAPUSA
- STOREY: G+2
- TYPE:RESIDENTIAL
- STOREY HEIGHT:3.4m
- EARTHQUAKE ZONE:3
- NO OF FLATS: FOUR 2BHK FLATS ON EACH FLOOR

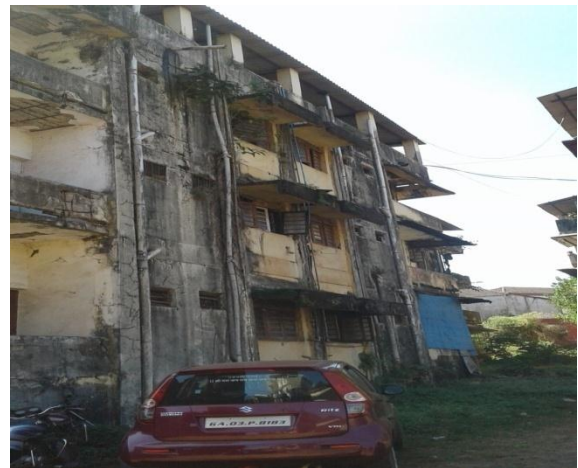
**Fig 3.1:** Junta Quaters

Year of construction-1968

Age- 49 years

Effects of monsoon - Yes

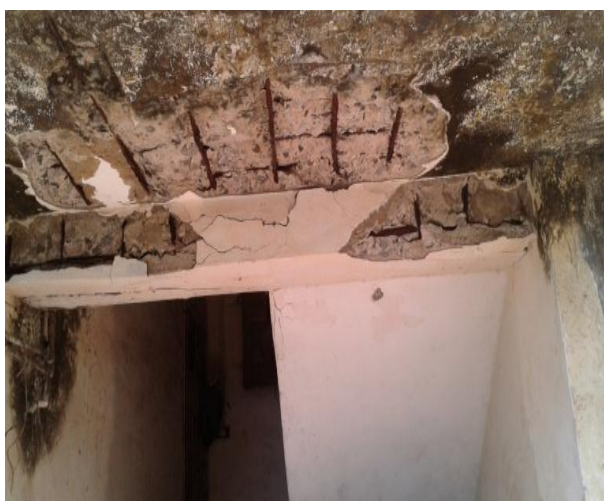
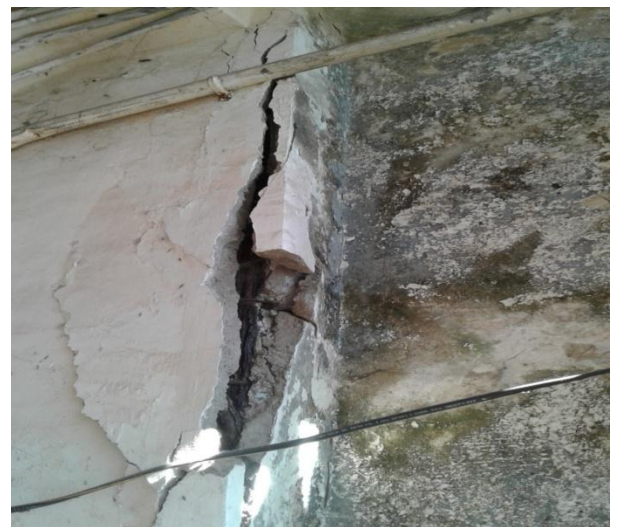
Fig 4.1: Cracks in structural members due to corrosion

**2. Tapping observation:** Column and beams of the building were subjected to tapping by the hammer .For some of the beams and column hollow sound was recorded. This hollow sound was due to loss of integrity between reinforced steel and surrounding concrete.

**Selection of critical area for further Non-Destructive testing:** Based on above observations flat no:2 of the ground floor was found most unsafe due to bad condition of structural elements such as beam, column and slab. Status of beams of this area is critical beams are sagging due to deflection and corrosion. There is bulging in column due to corrosion of reinforcement and disintegration of concrete has resulted in exposure of the reinforcement.

Structural building appears to be unsound due to external and internal defects. Structural members shoes cracks due to corrosion of the RCC members.

It is observed that main cause of damage of the structural members is due to corrosion and ageing. Corrosion in structural members is observed due to dampness and leakage from the slabs,cracks in walls ect.

Original strength of the RCC members can be restored by polymer modified mortar method.

### Rehabilitation of the RCC members

Propping the structure wherever necessary

Removing loose/disintegrated concrete

Cleaning the affected steel

Adding steel wherever necessary

Applying Passivator coat to the steel

Applying Bond Coat and doing Polymer /MicroConcrete treatment depending on the requirements

Finishing with new plaster

1. Polymer Modified Mortar Treatment
2. Jacketing to columns - Microconcrete.
3. Recasting of Slabs/ Chajjas
4. Water proofing Treatment
