## AJANTA CAVES: PAST PRESENT AND FUTURE

**Abstract** – The Ajanta caves are 30 rock-cut Buddhist cave monuments which date from the 2<sup>nd</sup> century BCE to about 480CE. It is located in Aurangabad district, Maharashtra, India having latitude of 20.5519°N and longitude of 75.7033°E.

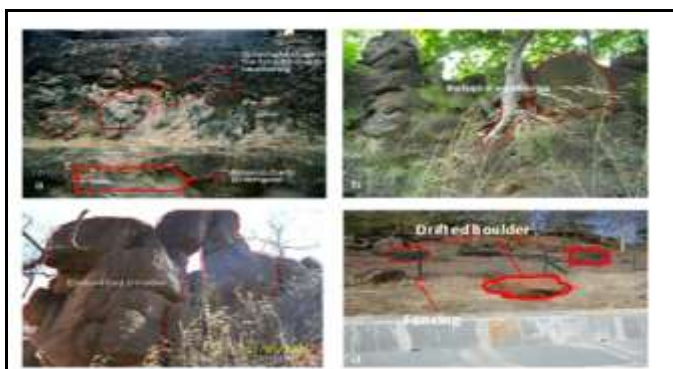
Figure 3: Various Types of Boulders in the Study Area

M.N Badge<sup>[1]</sup> et.al assessed and characterized the formation of boulders shown in Fig4 and suggested suitable stabilization measures. The boulder stabilization philosophy is based on the safety of tourists; keeping caves intact and considering stress distribution and deformation of the surrounding rocks. Techniques which could be planned for the stabilization of boulders suggested include: breaking down and removal of coarse boulders to reduce size of the unstable critical boulders; usage of epoxy resin based grouting to fill up the joints, discontinuities and cavities; application of rock bolting/ anchoring of unstable rocks in steep slopes; to reduce vulnerable bouldering, wire nets could be used and to maintain the esthetic value of the caves, camouflaging could be done. According to the study, the principles of engineering characterization of rock mass which was used along with proper human judgment was found to be useful in stabilizing the boulders. The priorities were given to the safety and stability of Ajanta caves by applying certain measures without altering the appearance of the caves. They have suggested the combination of various measures like epoxy resin/anchor bolting, wire net/mesh and catch net/draping.

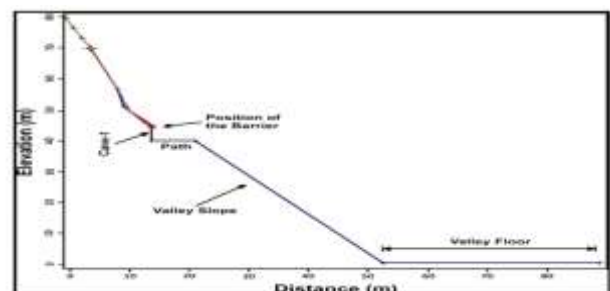
Figure 5: Critical Location of the Protection Barrier with Energy Capacity of the Order of 325kJ

M.K.Ansari<sup>[2]</sup> et.al conducted various tests on rock fall hazard to overcome the damage caused to the caves and for the safety of the tourists. Following tests were performed for studying the nature of rocks and their assessment: Barton-Bandis model in universal distinct element code from which test was done to obtain the information on detached rock mass; Rigorous Field study and laboratory experiment for rock simulation parameters; Rock fall 4.0 program for calculating maximum bounce heights total kinetic energies and translational velocities of the falling block of different weights shown in Fig 6. Their main focus of the survey was to study the description of slope geometry that was affected by rock falls and rock mass property. They have found that the reason for rock fall was due to downward forces acting on the rock mass changes which were due to pore pressure weathering of material, freezing/ thawing process and root growth with rock mass. As per the data obtained from the assessment they have concluded that the maximum of 917.66kJ kinetic energy for 2000kg mass and result showed that the kinetic energy was directly proportional to mass of falling rocks. The maximum translational velocity was found to be 40m/s and travelling up to a distance of 83m. Finally, they have concluded that the barrier capacity of 325kJ was calculated shown in Fig5 for 2000kg block of height of 50m to reduce the impact of rock fall.

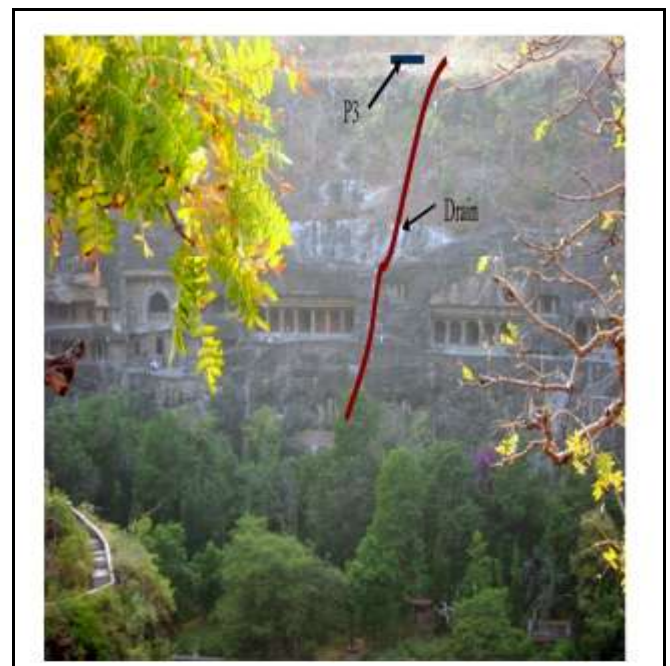
**Figure 8: Schematic Position of Profile P3 with respect to the Drain**

Paras R Pujari<sup>[3]</sup> et.al used Ground Penetration Radar (GPR) technique to detect seepage pathways in Ajanta caves. Reconnaissance survey was carried out to decide the survey parameters and select appropriate antenna frequency. GPR tool was used in finding the presence of fractures which may be the pathways for seepage into the caves. The data were collected by 40 and 200MHz antennas from geophysical survey systems, Inc. (GSSI). The data were edited and processed using the RADAN 6.5 software. The reflective zones indicated the fractures and strong absorbance zones showed homogeneous zone without any fracture. The positions (latitudes and longitude) of the profiles were acquired with the help of Garmin hand held GPS system. Based on the field condition GPR scans were obtained at 6 profiles in the study area. All profiles were subjected to fractures which vary with respect to their thickness, type and orientation. The massive compact basalt was found below 10m in profile P1 which resulted seepage at cave1. Presence of quartz veins shown in Fig7 at profile P2 contributed to fractures in cave 17 and 20. The profiles P3 shown in Fig8 and P4 indicated distinct patterns of fractures which were inclined in nature. The fractures in radar section were seen in profile P5 that caused dry condition in underlying caves 25 and 26. Profile P6 indicated fractures below 10.5m depth above which they it was seen to be homogeneous. From the data obtained from these profiles they have concluded that seepage can be avoided by providing proper drainage

To control seepage in mainly in profile P3 Bentonite shown in Fig11 clay minerals can be used near the drain path as indicated by red line in Fig8. Bentonite becomes hydrated with the moisture naturally present in soil and acts as impermeable barrier that absorbs and expels water. Hence an effort can be made to protect the world heritage site.

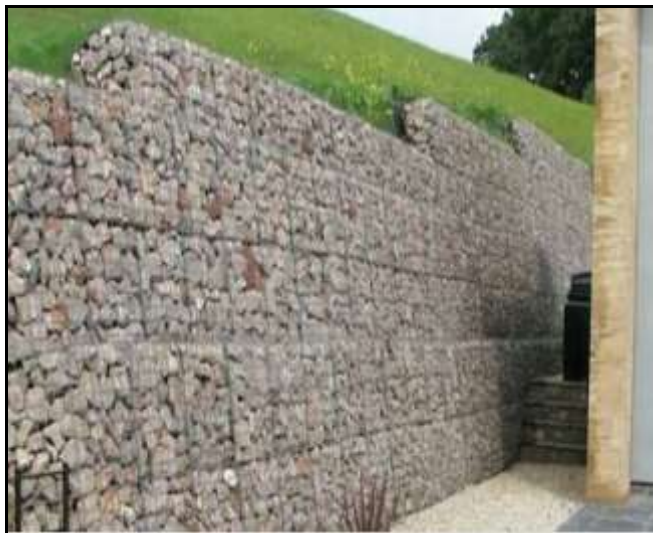
**Figure 9: Gabion Wall**

Gabion walls as shown in Fig9 which are wire baskets filled with rocks for steep slopes are majorly used in cave 3

and cave5. They are used by considering its flexibility to conform to difficult site geometry, prevents building up of water pressure, it is economical and rate of construction is faster.

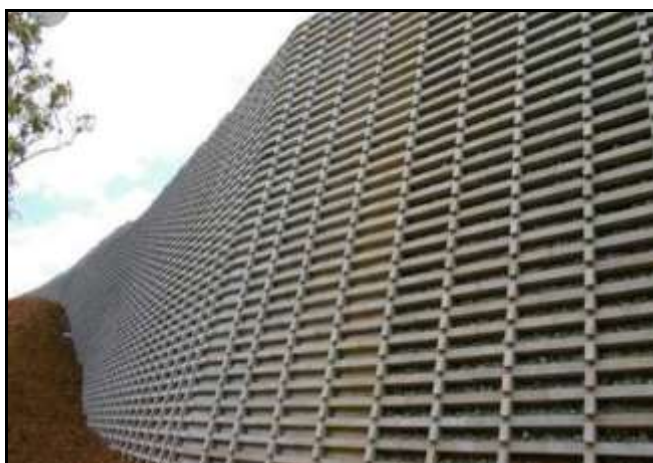
**Figure 10: Crib Wall**

Crib walls shown in Fig10 which act as retaining walls, helps in slope stabilization, controls erosion and acts as rock fall protection for cave1 and the pathway for visitors.
