Adaptive Reuse- A Case of Lal Baradari, Lucknow

4. LAL BARADARI

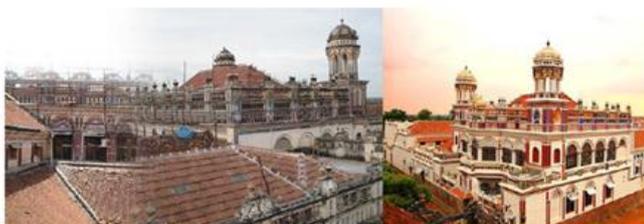
Fig. 1: Chittinadu Mansion

The reuse of a heritage or existing building becomes necessary for its social, economic and cultural sustainability. One such historic building, 'Chidambara Vilas' at Chettinadu region, Pudukottai, Tamil Nadu, India is a 110 year old palatial mansion once a residence of a Nattukottai Chettiars, today turned in to a heritage hotel.

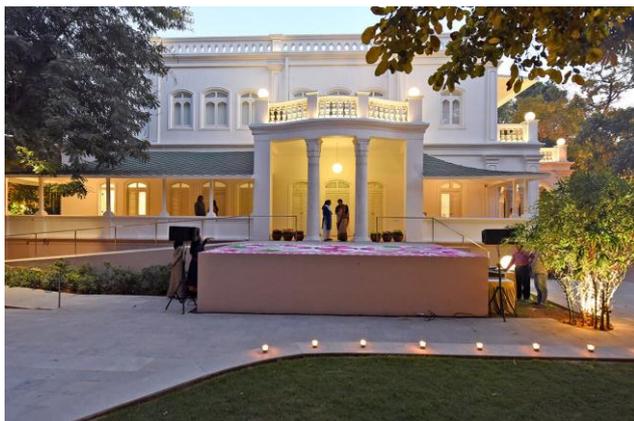
Fig. 4: Lalbhai Museum

The main building – the colonial home built in 1905, which was home to the Lalbhai family until the 1980's, typically a conglomeration of single storied rooms, has been restored to its past glory. It now houses the family's modest collection, eclectic in nature, showcases art and antiquities, perfectly balancing historical merit with personal favourites; all the while retaining the essence of the family home.

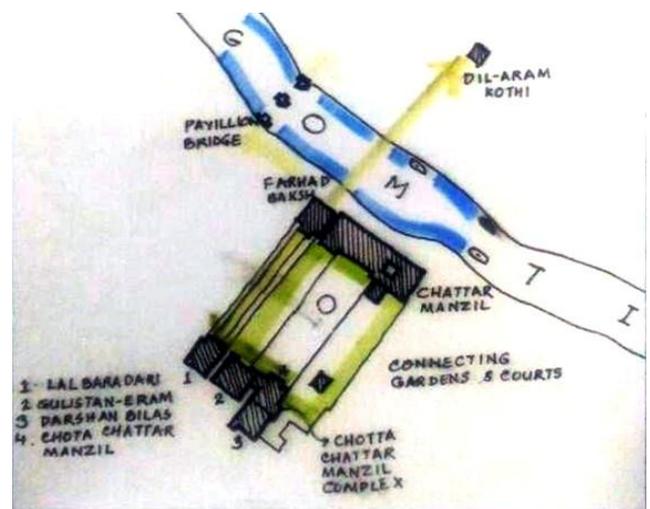
Fig 5: Site Plan, Lal Baradari

Building was not responding to its original fabric. The building is enclosed with various other structures and the heritage importance and significance is getting lost. Unsympathetic alterations and additions were done just to run a department without maintaining the integrity and dignity of the original built fabric / built structure.

Both the Interior spaces and the external facades has been altered according to the need of the department. It includes the false ceiling which was added initially, the sanitary pipes, and electric wire conduit removal of vault and in place of the vault addition of slab. Present defects in the structure / alterations / additions were done for various purpose. The

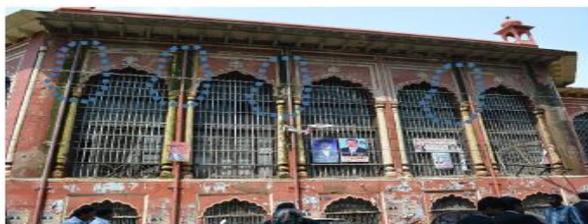
Fig 6: Walls, Lal Baradari

Building was not responding to its original fabric. The building is enclosed with various others structures and the heritage importance and significance is getting lost. Unsympathetic alterations and additions were done just to run a department without maintaining the integrity and dignity of the original built fabric / built structure.

Deterioration of wall due to weathering and water seepage

Vegetation and algae growth

Partial expose of brick work

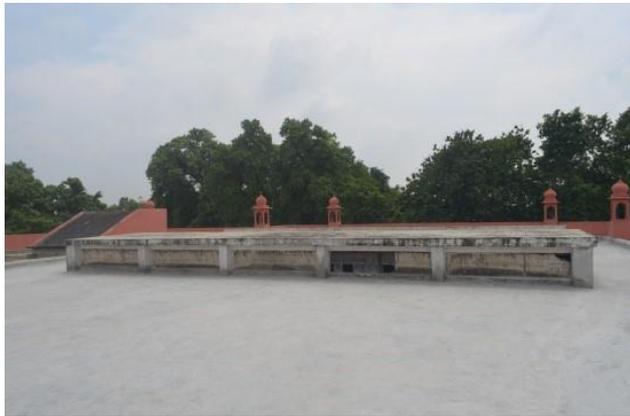
Fig 8: Roofs, Lal Baradari

In previous insensitive restoration works, the roof of the historic monument have been covered with a thick layer of

almost 100 to 150mm of concrete leading to structural issues such as increase in dead load on the building. Due to incompatible material the concrete and lime have not bonded well leaving the gaps between the two materials, which leads to seepage and dampness.

The thick concrete acts as a thick membrane not allowing the excessive moisture to evaporate leading to decay and deterioration of the original roof structure which is historically significant.

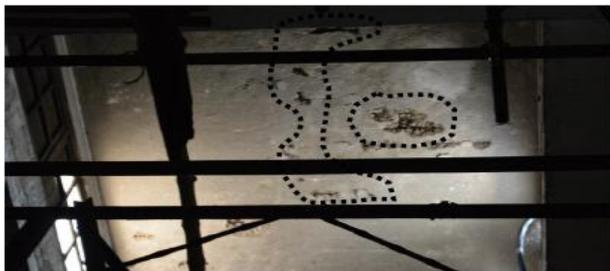
Fig 9: Slabs, Lal Baradari

Vaulted slab resting on an I-Section

Suspended cables to the ceiling

Development of crazing in the slab

In some part of the monument, electric cables have been suspended to the ceiling which might damage the ceiling.

Crazing can also be seen in the slab which is a cosmetic defect and not a structural concern the defect needs to be evaluated.

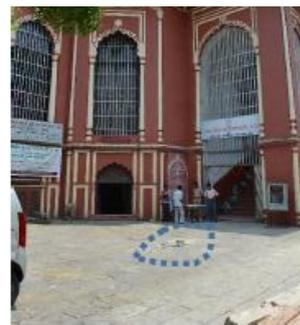
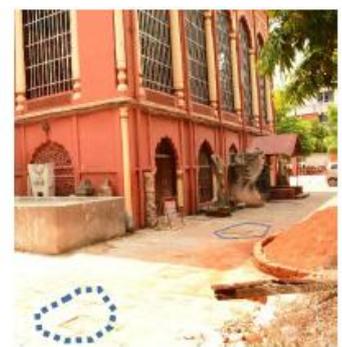
Fig 10: Flooring, Lal Baradari

The flooring work of the exterior portion has been done with the hand chiselled red sand stone blocks. Several damages are in the flooring. It seems as if the level is raised above the original level as the building ground floor is below the external level.

The flooring in the ground floor has been redone using cement mortar. The flooring on the upper floors has also been done in cement whereas in several parts we can also find the original flooring. The stairs are paved with red sand stone. On the first floor several cut-outs have been made with a fixture of translucent glass to provide the penetration of natural light. Deterioration & Damages in the interior flooring can also be seen.

Damage in the exterior flooring

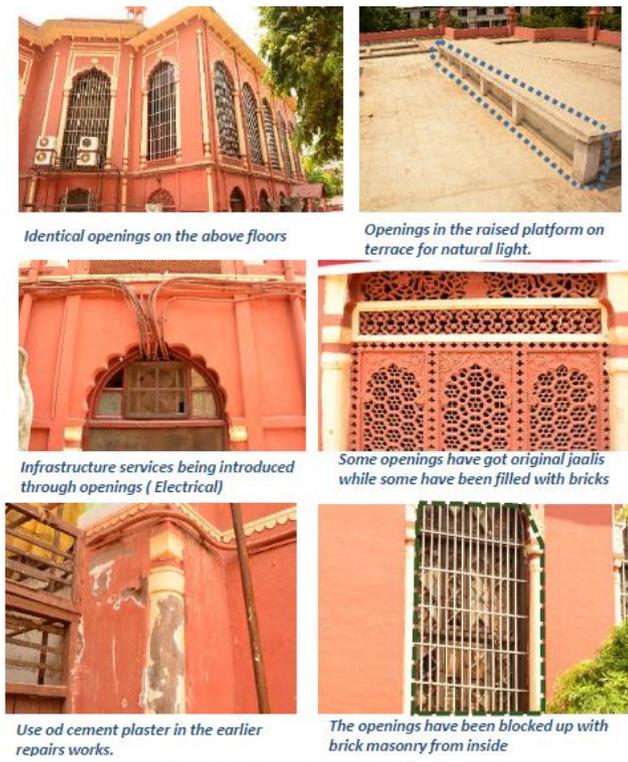
Fig 11: Openings, Lal Baradari

There are no ornamental/decorative patterns over the arches and pillars at ground floor whereas, decorative pillars with vertical grooves can be witnessed at the upper floor and so may be the case in the lower arches which in due course of time and in previous insensitive repairs had been covered while the restoration process. There are signs of insensitive repairs with the cement based mortar over the arches and pillars.

Except the two major openings leading to the upper floors have been covered with iron grills and jallies and partially or completely closed with the brick work behind them. Not allowing the building to breathe naturally resulting in the dampness inside the building.

In Above floor arches, each openings has got foliated arches with decorative work of stucco done on it and with the specialty of non-repetitive patterns over them. The original doors and windows are deteriorating and decaying due to negligence and lack of maintenance. Openings on the roof have now been covered with the RCC Structure on a raised platform with ventilators at its side for light and air (which are generally closed).

The cut out in the slabs made for the light to enter from above and lighten up has gone meaningless as there is no sufficient light in the above floors as the openings have either being closed or covered.

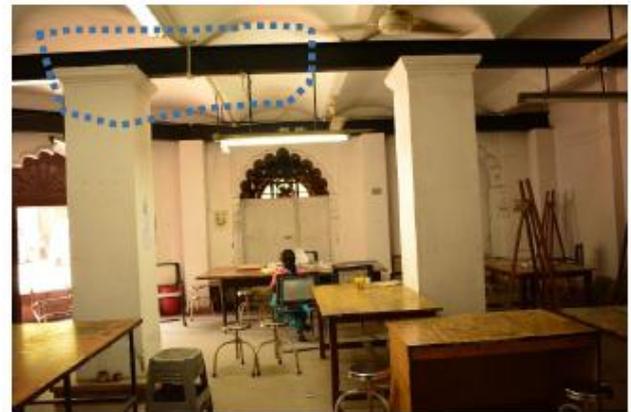
Fig 12: Structural Systems, Lal Baradari

An I-Section has been used which runs through the each end of the vault acting as a tension member & the load of vaulted slab is then transferred to the columns which is a compression member.

I-section running through each end of vaults finally transferring the load to the columns

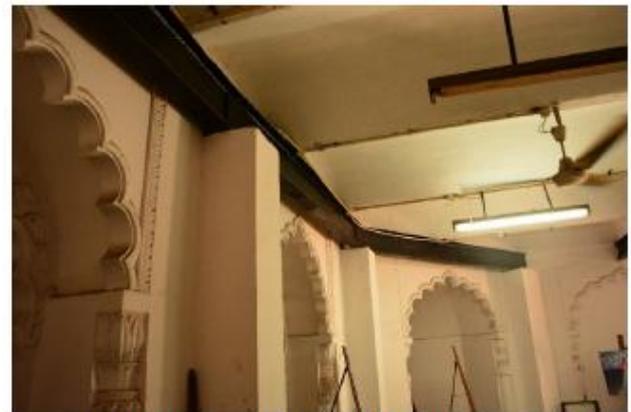
The building is construction on load bearing structure with arches carving out the opening to various places and helping in reducing the load as well as in equal transfer of load.

Arches and columns transferring the load to the ground at the ends.

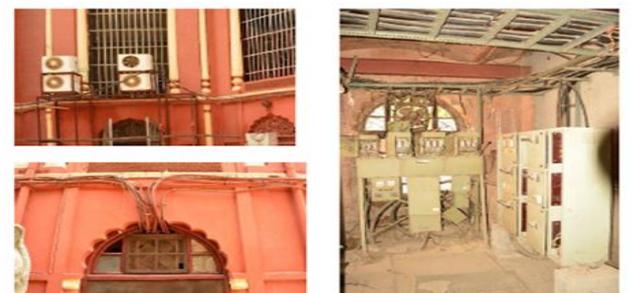
Fig 13: Infrastructure Addition, Lal Baradari

Electrical supply services made in open and may lead to any accidents.

Various electrical services have been inserted into the building in a in appropriate manner disturbing the visual aesthetics of the building.

The electrical cables and wires are running haphazardly in the building. There is no separate electrical room outside the building as main supply room is being made inside the building only which is not appropriate seeing the historic significance of the building & may lead to any accidents, mainly in case of any short-circuit, which may lead to fire and thus damaging the building.
