CONDITIONAL ASSESSMENT OF BRIDGES

CASE STUDY: KUND-MALA BRIDGE

4. CASE STUDY: KUND-MALA BRIDGE

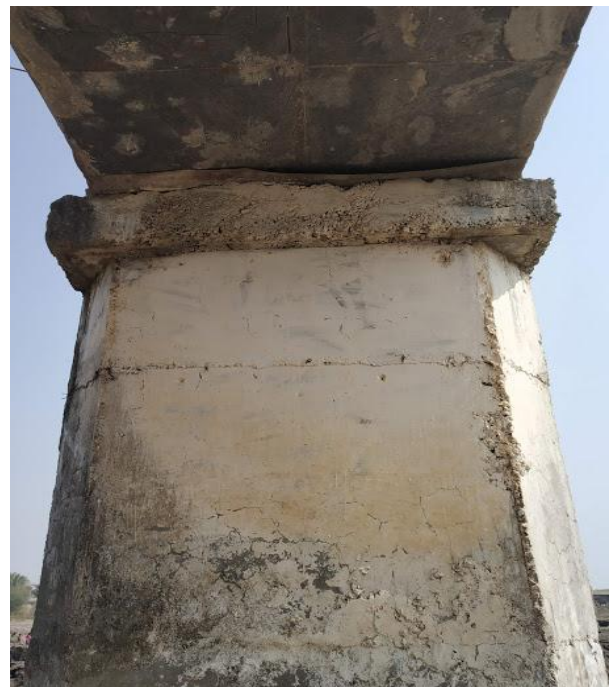
- a) Formation of cracks in slab and column in all direction. These were observed in concrete bridge. The cracks detected are both structural and non-structural type.

Fig.2 Development of structural crack perpendicular to the axis of pier

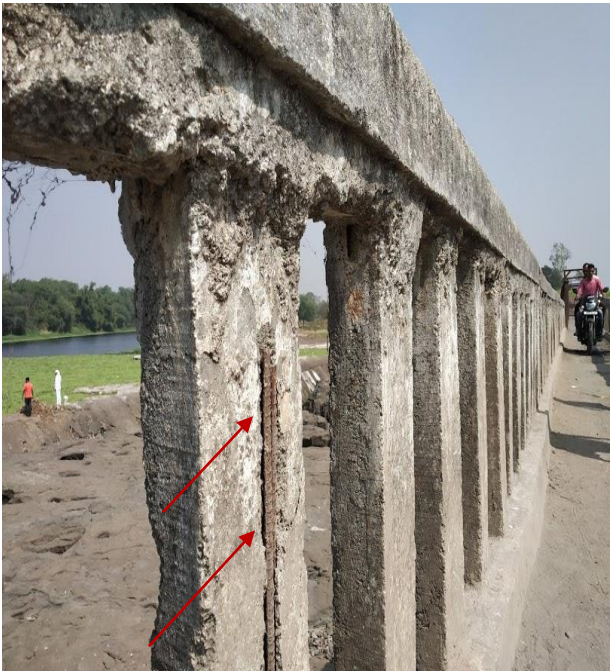
- b) Growth of vegetation across wing wall and piers of concrete bridge has taken place. This has led to reduction in strength of piers.
- c) Steel reinforcement from slab and parapet wall surfaces has been exposed. Adverse effects of moisture and temperature is taking place on the reinforcement.

Fig.3 Reinforcement exposed in parapet wall causing decrease in strength in member

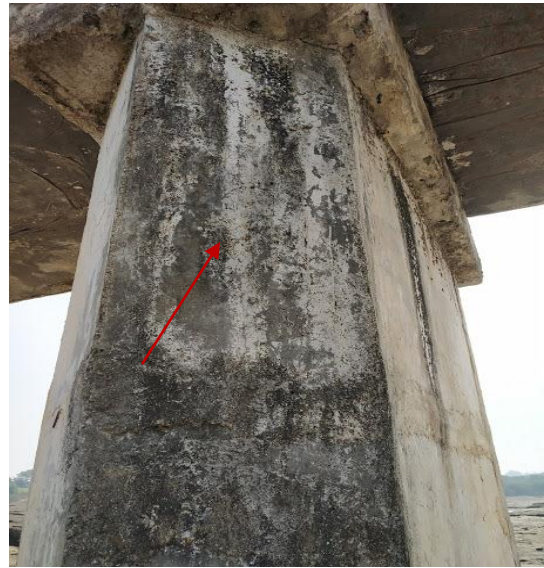
- d) Efflorescence effect has taken place due to moist conditions and uneven rainfall.
- e) Due to flow of river base of piers has been eroded in concrete bridge.

Fig.5 Efflorescence effect over the surface of pier

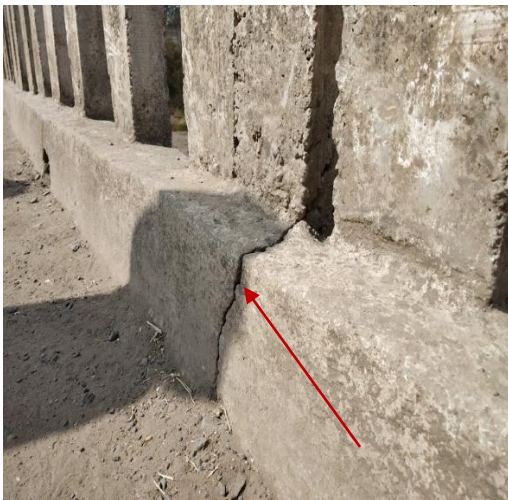
- j) The parapet walls has been broken and damaged.
- k) Loading conditions have changed over the bridge as movement of vehicular traffic (2-wheeler) has increased on it. This has led to increase in the vibrations of the bridge.
- l) Scouring effect has taken place due to uneven flow of the river. This has exposed the foundation base completely.

Fig.4 Non-structural crack developed in parapet wall

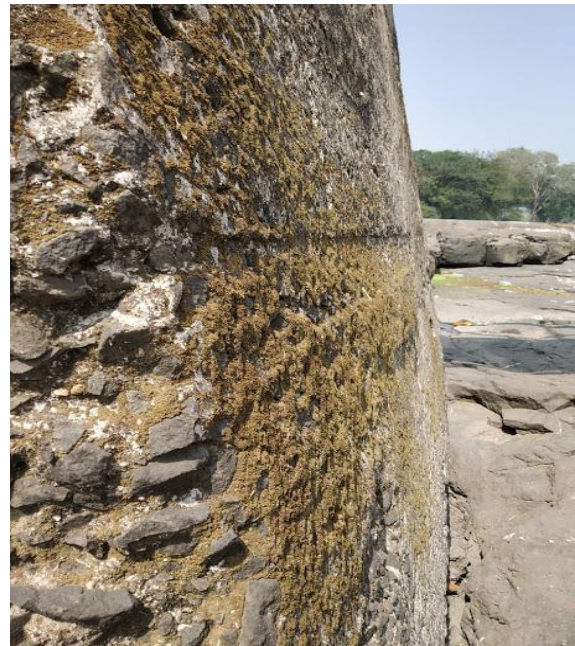
Fig.6 Growth of vegetation over surface of stone masonry pier

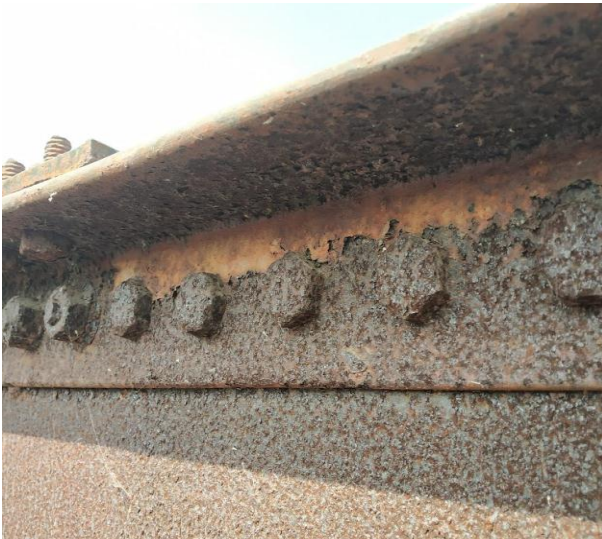
- f) Steel surface in truss segment has completely corroded due to environmental conditions and lack of painting and plastering.
- g) Members of trusses have deformed and breakdown.

- h) Connection of trusses having rivet and bolts has created rupture along gusset plates.
- i) There is no safety provided across truss bridge, which results in severe accidents.

Fig.7 Rusting of the joints of steel truss bridge

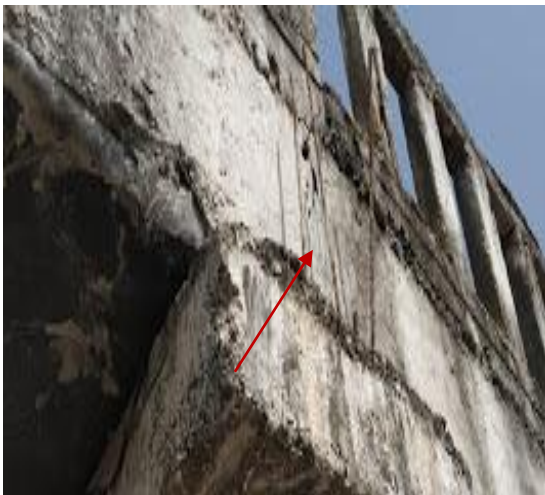
Fig.8 Exposed reinforcement covers of the slab member

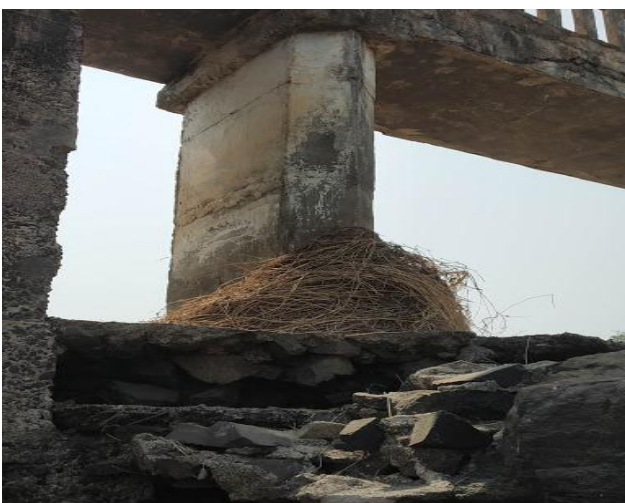
Fig.9 Scouring effect on foundation as well as growth of vegetation
