“REPAIR AND REHABILITATION OF A BUILDING”

Abstract :- information regarding this paper discusses the review of repair and rehabilitation of building. In current scenario of building research, repair and rehabilitation plays vital role as it serves important in building application. The structural examination under sect. 353(B) of the Bombay munciple corporation act, 1888. As per request of managing committee of the building. We have inspected “YASHASHREE C.H.S. LTD,” situated anant nagar, kulgaon badlapur, badlapur (E). Tal Ambernath, Dist thane- 421503.

We have inspected the building and check the building component for the purpose to find out current structural condition. The report is best mainly on visual inspection and NDT Test. The building is RCC Frame structure with Brick walls. The building is consisting of G+2 storied. As compare to the building the intensity and damage and deterioration is indicatively severe and exhibits. As the extended movement corrosion of the steel reinforcement take place. Overall structural condition of the building does not look to satisfactory since the building elements are affected by reinforcement corrosion externally and internally. Some r

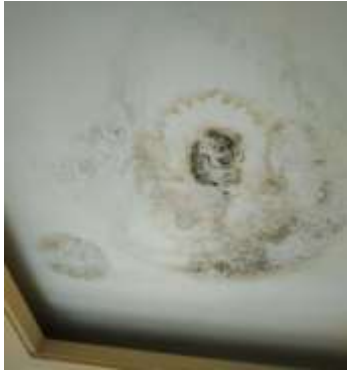
Fig. 2.2 de-lamination of concrete cover due to severe corrosion of roof slab

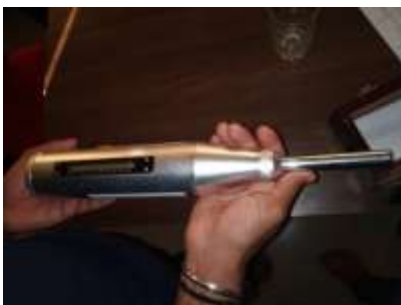
- Assessing the compressive strength of concrete with the help of suitable correlation between rebound index and compressive strength
- Assessing the uniformity of the concrete
- Assessing the quality of concrete in relation to the standard requirements
- Assessing the quality of one element of concrete in relation to another

Fig. 3.1 rebound hammer test

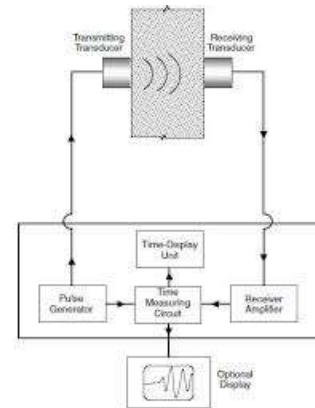
- the homogeneity of the concrete
- the presence of cracks, void and other imperfections
- changes in the structure of concrete caused by exposure condition, corrosion, wear etc. Which may occur with time
- the quality of concrete in relation to the specified standard requirements.
- The quality of one element of the concrete in relation to the another
- The values of the dynamic elastic modulus of the concrete

Fig. 3.2 Ultrasonic pulse velocity test
