Structural Audit of Building: A Structural Health Analysis of Building

Site Name: Siddhivinayak Park Co-Operative Housing Society

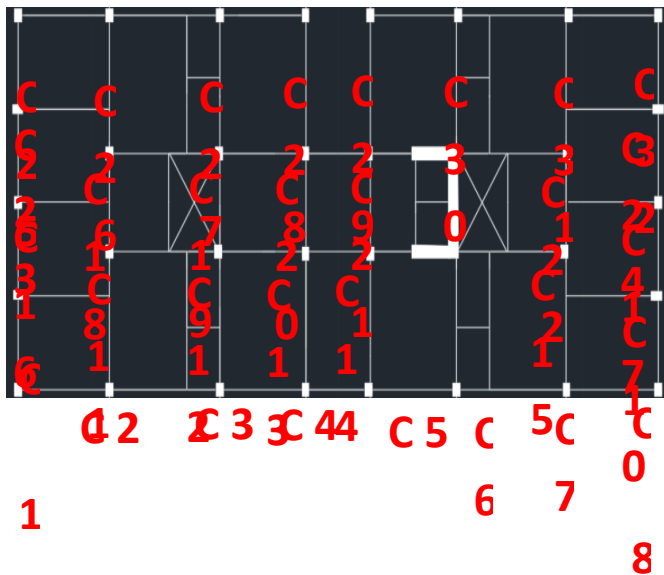
FIG No.1. Coulum Plan For Building

TABLE -1: Column sizes

Column Name	Column Size
C1,C2,C3,C6,C7,C8,C11,C12,C15,C16,C17,C18,C19,C22,C25,C26,C27,C30,C31,C32	300X450mm
C9,C10,C23,C24	350X230mm
C4,C5,C13,C14,C20,C21,C28,C29	230X350mm

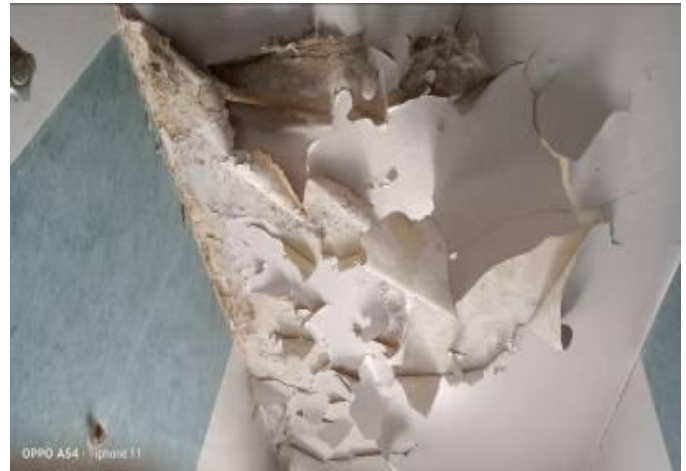
Image 1: Peeling of colour is observed at A-03 flat

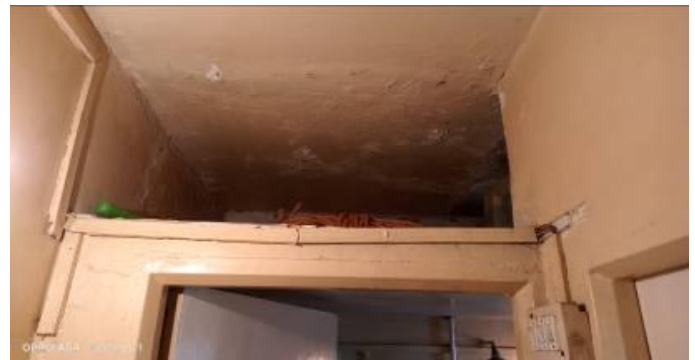
Image 2: Dampness and Colour Peeling in C1 06 flat

- For the dampness in the area add 25-30% water to Dr. Fixit Wonder proof 1 to make a slurry coating.
- To fill the voids, cracks some joints Injection Grouting is to be carried out.
- Maxtreat Fibrenet C is a carbon fiber composite system is used for to provide adequate strength to the structural elements such as beams, columns, bridges, slabs and walls.
- To cure spalling and damaged concrete in buildings, DUAL Shrinkage Compensated, Trowelable Fiber Reinforced Thixotropic Repair Mortar can be used

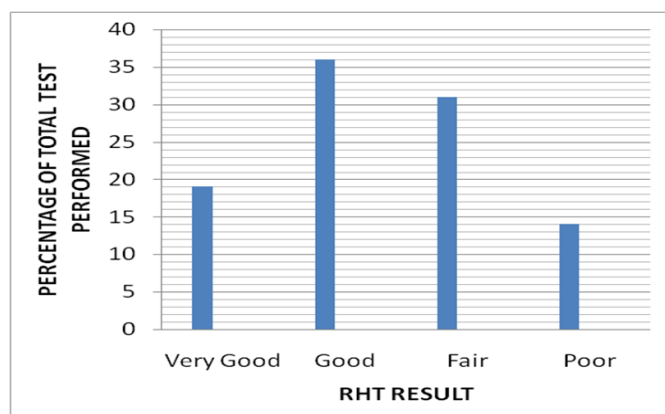
Graph-1: RHT Results Performed on various parts of structure

RHT is performed based on the (Clause 3.2, Page No. 1, IS 13311 Part 2). The hammer first calibrated on previously known strength of concrete and test is performed on various structural elements.

On performing Rebound Hammer Test it is found that 14% of total Structural Elements Tested are comes under the poor condition while 19% of them are falls under Very

Good Category of Condition as per Is 13311:2009 part 2 (from Graph 1)

3. On performing Rebound Hammer Test it is found that 14% of total Structural Elements Tested are comes under the poor condition while 19% of them are falls under Very Good Category of Condition as per IS 13311:2009 part 2 (from Graph 1).

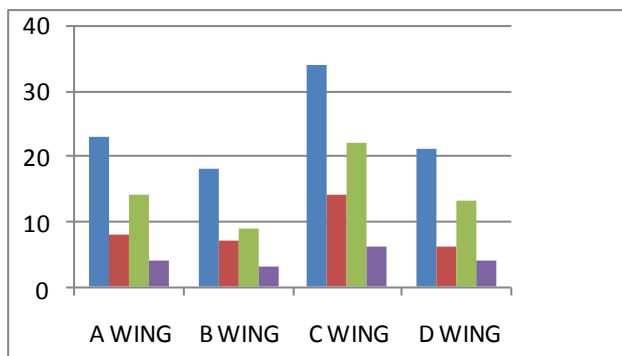
Graph 2: On X axis wing is shown while on Y axis percentage vulnerability towards different parameters is shown

Blue Colour : Cracks
 Red Colour: Colour peeling
 Green Colour: Dampness of leakage
 Violet Colour: Vegetation

Structural Elements of Wing C building is more vulnerable towards the cracking of concrete defect which is around 34% of the total defects found (from graph 2).

2. Structural Elements of Wing C building is more vulnerable towards the cracking of concrete defect which is around 34% of the total defects found based on visual inspection performed

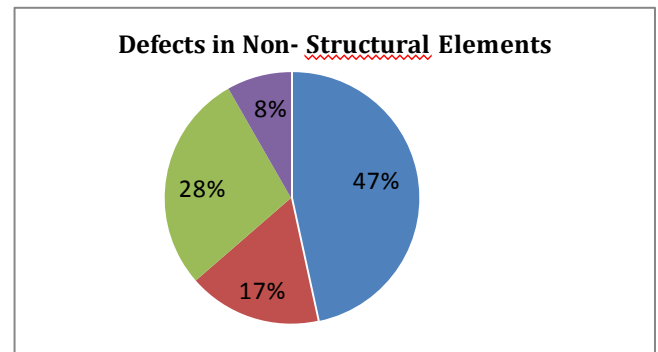
Pie chart 2: showing comparison of structural defects

Blue Colour : Cracks
 Red Colour: Colour peeling
 Green Colour: Dampness of leakage
 Violet Colour: Vegetation

It is found out that among all the defects category Cracks are the most that is, 47% which defects due to vegetation found out to be least that is, 8% (from pie chart 2).
