Vibration Signature Analysis of 4 Jaw Flexible Coupling Considering Misalignment in Two Planes.

Sanjiv Kumar

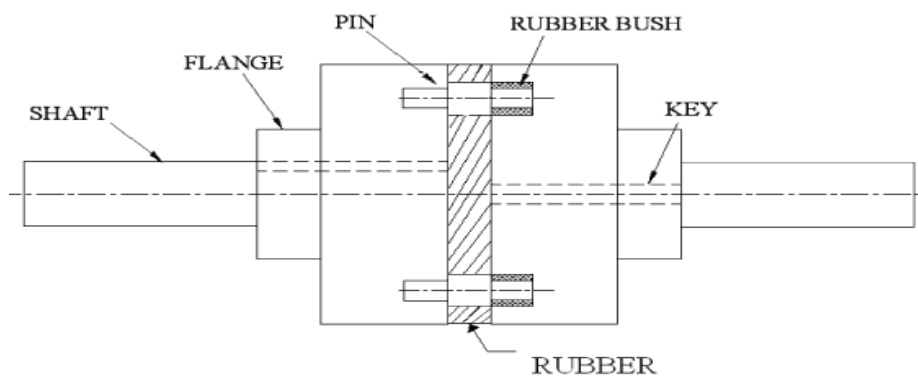
Fig. 1 Four Jaw flexible coupling with key and shaft

A 4 Jaw coupling is as shown in Figure 1. It has two flanges. One flange has a pin hole of required number at pitch circle diameter. The other flange will have a number of pins projected outside at pitch circle diameter to accommodate into the first flange holes with rubber bush. The driver and driven shafts are connected to their respective flanges i.e. output and input flanges by means of parallel square key. Mild-steel is considered for the input and output shafts, pins and keys. Over these pins, a circular natural rubber bush is provided and its length is equal to the length of the hole. The diameter of the flange holes is equal to the diameter of pin plus the thickness of rubber bush. The cast-iron material is chosen for both left and right flanges and the natural rubber is for bush. There is no nut and bolt to clamp the both input and output flanges. The Figure 1 represent the two dimensional model of 4 Jaw flexible coupling. In between flanges a rubber material is introduced to give the flexibility. Dimensions of the coupling and materials used are given in Table 1 and Table 2.

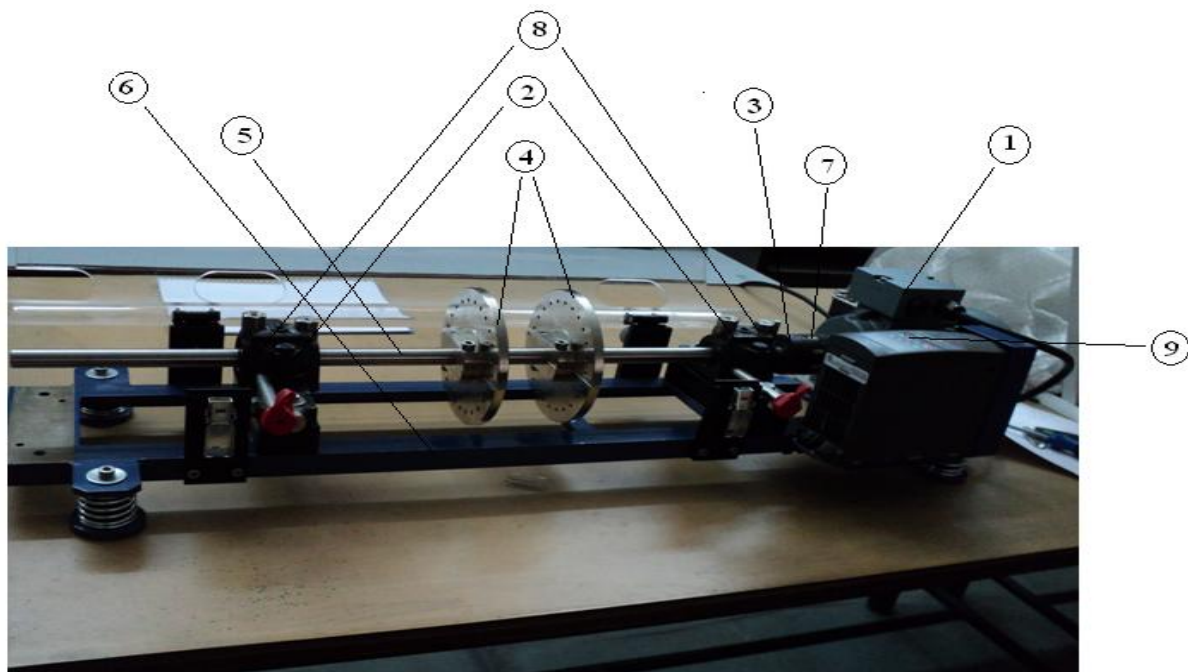
Fig. 3. Photograph of Experimental set up with two rotors at intermediate position in 2 planes

The Experimental apparatus is shown in Figure 2 (two rotors in overhung position in two planes) and in Figure 3 (two rotors in intermediate position in two planes). It consists of a D.C. motor, a flexible coupling and a double disk rotor. The rotor shaft is supported by two identical ball bearings and has a length of 660 mm with a bearing span of 460 mm. The diameter of the rotor shaft is 20 mm. Two disks of 128 mm in diameter and 10 mm in thickness are mounted on the rotor shaft non drive end. The bearing pedestals are adjustable in vertical direction so that different misalignment conditions can be created. The rotor shaft is driven by 0.75 hp D.C. motor. The D.C. voltage controller known as control panel is used to adjust the power supply so that motor speed can be continuously increased or decreased in the range from 0 to 3000 rpm. The baseline signal has been measured at a rotor speed of 30 Hz. to check the concentricity.

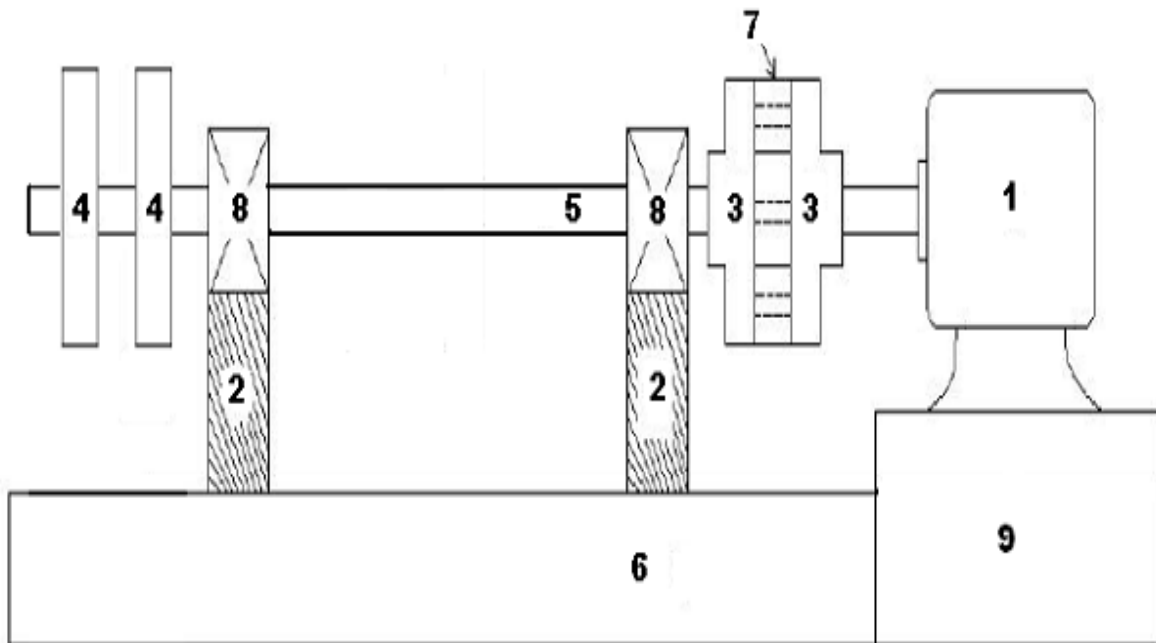
Fig. 4. Experimental set with two rotors at overhung position in 2 planes

Experimental facility as shown in Figure 2 (with two rotors in overhung position in two planes) is used for both baseline and unbalance tests. First the setup is run for few minutes to settle down all minor vibrations. Before creating unbalancing, the shaft is checked for any misalignment and unbalance. After that an unbalance has been created by placing a mass of 18 gram in the overhung rotor at a radius of 54 mm. Accelerometer along with the vibration analyzer is used to acquire the vibration signals. The accelerometer is attached with the help of wires to take readings at three positions (Horizontal, Vertical and Axial) at NDE (Non Drive End) and DE (Drive End) for both motor and rotor. Following are the three positions for motor and rotor:

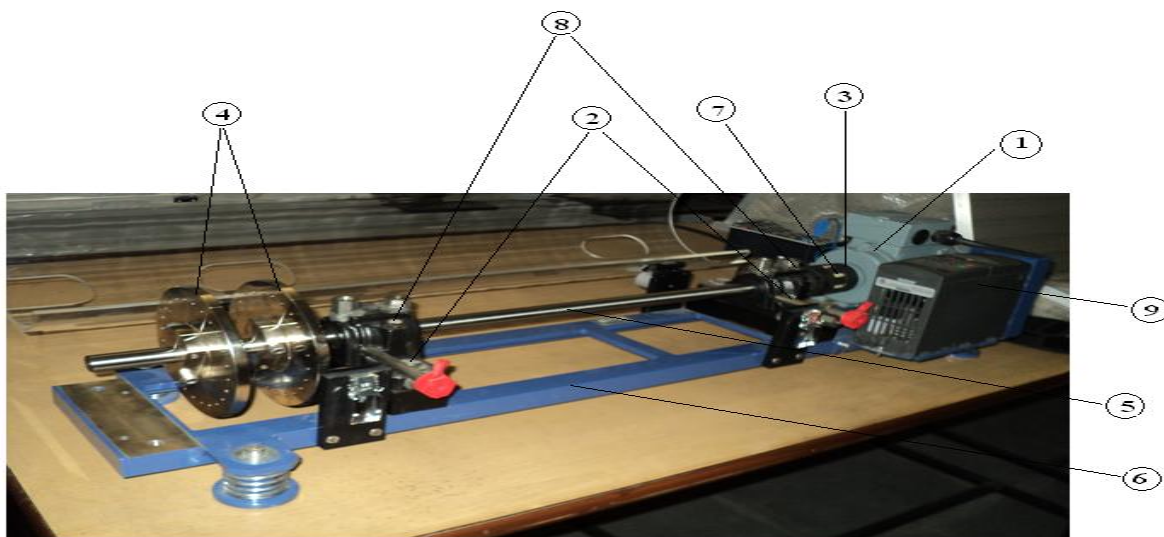
Fig. 5. Photograph of Experimental set up with two rotors at overhung position in 2 planes

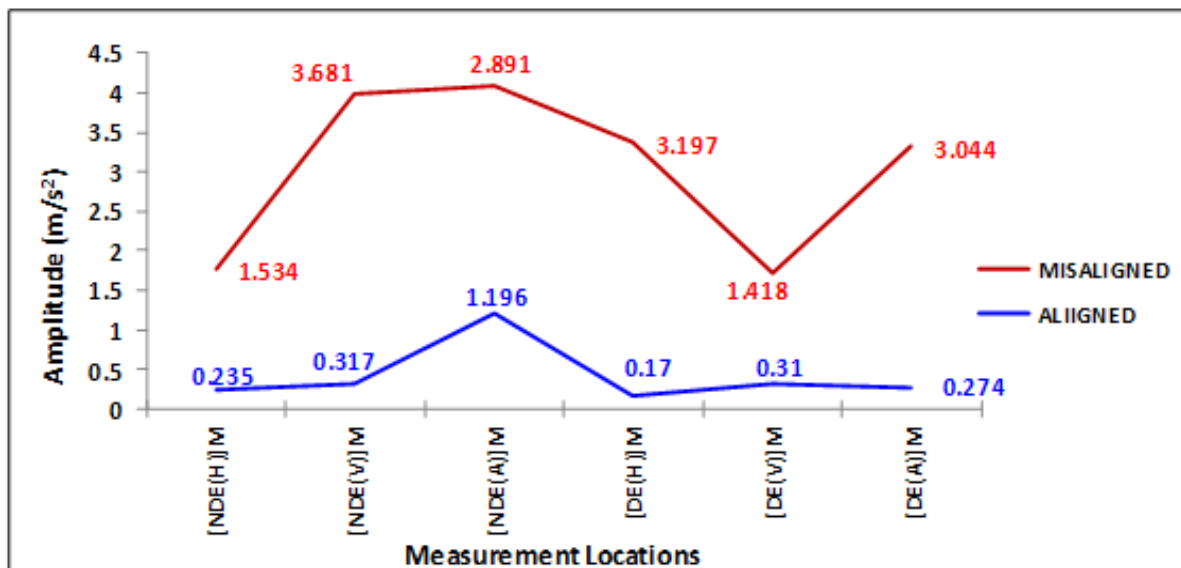
Fig. 6 Amplitude trends of NDE & DE of both motor and rotor in baseline and misaligned conditions with two rotors in INTERMEDIATE POSITION along MOTOR SIDE

The experimental frequency spectra were obtained to the baseline condition. The perfect alignment and balancing cannot be achieved in practice. Thus, a baseline (well aligned) case is presented first to show the residual misalignment. The graphical comparison measured amplitude trend of vibrations in the form of acceleration of a baseline AND misaligned system at Drive End (DE) and Non Drive End (NDE) with 4 Jaw flexible coupling at a frequency of 30Hz (1800 RPM) is shown in figure 6. The baseline spectrum is measured experimentally using dual channel vibration analyser. Table 3 & 4 shows the comparison of experimental vibration amplitudes when two rotors are in intermediate position for both baseline and misaligned signals on MOTOR SIDE and ROTOR SIDE respectively. Figure 6 shows that the max. amplitude 3.681 m/sec^2 is observed in red curve at **[NDE (V)]_M** in misaligned condition but when the system is aligned a lower amplitude of 0.317 m/sec^2 is observed in blue curve at same location. This shows the dangerous level of misalignment. In this figure it can be seen that the amplitude trend changes from 1.534 m/s^2 to 3.044 m/s^2 with peak amplitude of 3.681 m/sec^2 in case of misaligned rotors at all different

locations whereas for aligned or baseline case the amplitude changes from 0.235 m/s² to 0.274 m/s² with peak amplitude of 1.196 m/s² only. Similarly, for Figure 7 at the same location but along rotor side [NDE (V)]_R the maximum amplitude reaches 6.399 m/s² for misaligned rotors but for aligned rotors this value is just 0.344 m/s². In this case the amplitude for misaligned rotors changes from 1.233 m/s² to 4.853 m/s² with peak amplitude of 6.399 m/s² whereas for aligned or baseline case the amplitude changes from 0.155 m/s² to 0.134 m/s² with peak amplitude of 0.344 m/s² only.

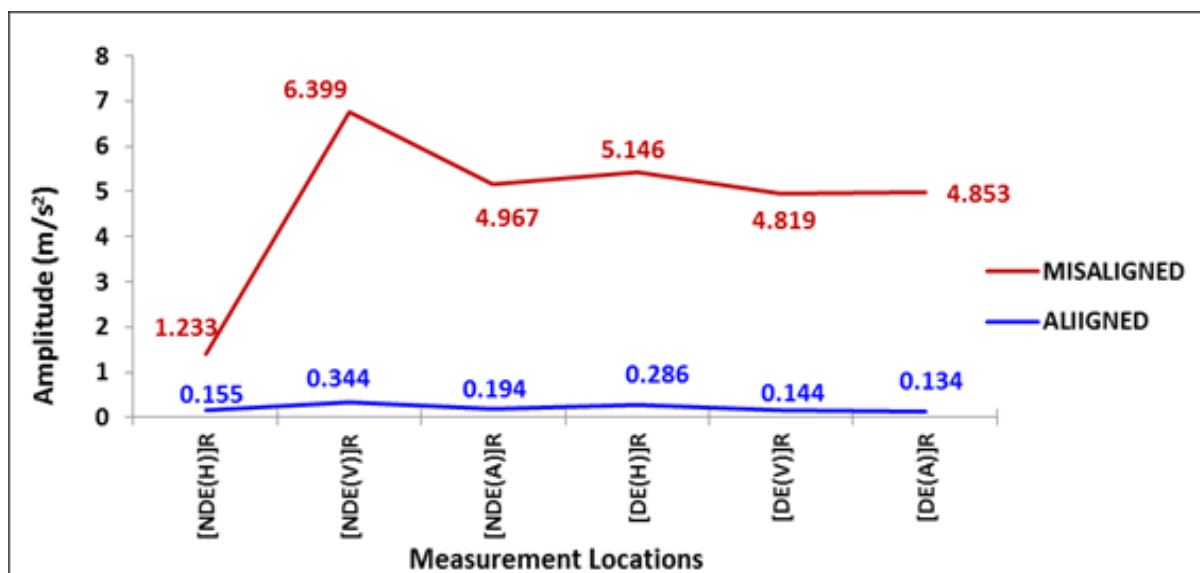
Fig. 7 Amplitude trends of NDE & DE of both motor and rotor in baseline and misaligned conditions with two rotors in INTERMEDIATE POSITION along ROTOR SIDE

This highest amplitude at this location is due to the residual forces acting on the system. Small amount of peaks at harmonics of shaft speed are the indications of manufacturing errors of coupling and other elements like rubber pad or rubber bush that cannot be eliminated. From the vibration spectrum of both DE and NDE for motor and rotor it is also observed that the 4 Jaw flexible coupling produce different amount of vibrations at different rotor locations discussed in this paper (2 overhung & 2 intermediate). So it is concluded that, 4 Jaw flexible coupling is to withstand much vibrations at different rotor locations. Experimental amplitudes are very accurately measured.

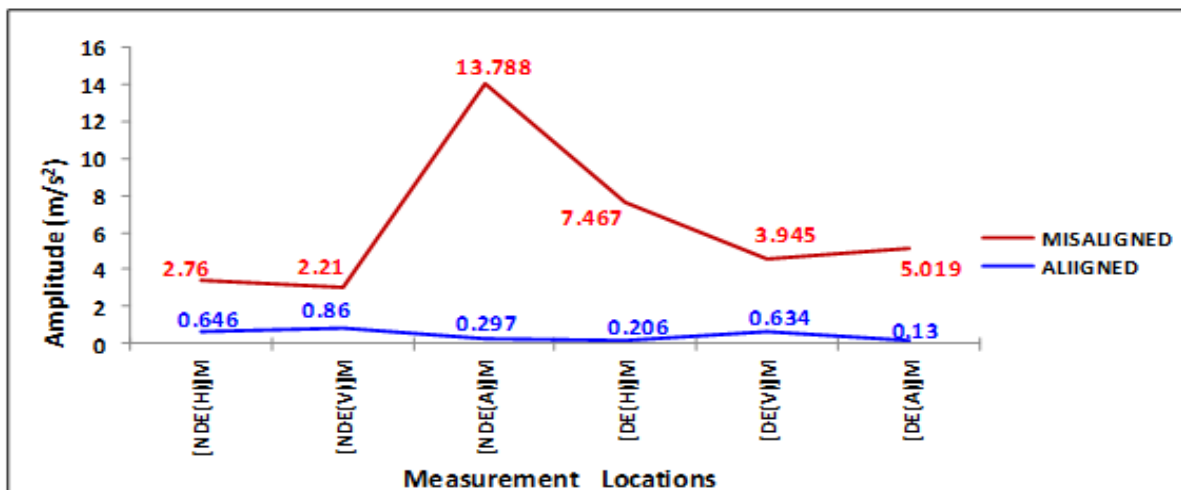
Fig. 8 Amplitude trends of NDE & DE of both motor and rotor in baseline and misaligned conditions with two rotors in INTERMEDIATE POSITION along MOTOR SIDE

The experimental frequency spectra were obtained to the baseline condition. The measured amplitude trend of vibrations in the form of acceleration of a baseline AND misaligned system at Drive End (DE) and Non Drive End (NDE) with 4 Jaw flexible coupling at a frequency of 30Hz (1800 RPM) is shown in Figure 8 & 9. Table 5 & 6 shows the comparison of experimental vibration amplitudes when two rotors are in overhung position for both baseline and misaligned signals on MOTOR SIDE and ROTOR SIDES respectively. Figure 8 shows the maximum amplitude 13.788 m/s^2 is observed in red curve at $[\text{NDE (A)}]_M$ in misaligned condition but when the system is aligned a lower amplitude of 0.297 m/s^2 is observed in blue curve at the same location. This shows the dangerous level of misalignment. In this figure it can be seen that the amplitude trend changes from 2.76 m/s^2 to 5.02 m/s^2 with peak amplitude of 13.788 m/sec^2 in case of misaligned rotors at all different locations whereas for aligned or baseline case the amplitude changes from 0.65 m/s^2 to 0.13 m/s^2 with peak amplitude of 0.86 m/s^2 only. Similarly, for Figure 9 at a different location of $[\text{NDE (H)}]_R$ along rotor side the maximum amplitude reaches 9.25 m/s^2 for misaligned rotors but for aligned rotors this value is just 0.204 m/s^2 . In this case the amplitude for misaligned rotors changes from 9.25 m/s^2 to 1.45 m/s^2 with peak amplitude of 9.25 m/s^2 whereas for aligned or baseline case the amplitude changes from 0.204 m/s^2 to 0.105 m/s^2 with peak amplitude of 0.635 m/s^2 only.

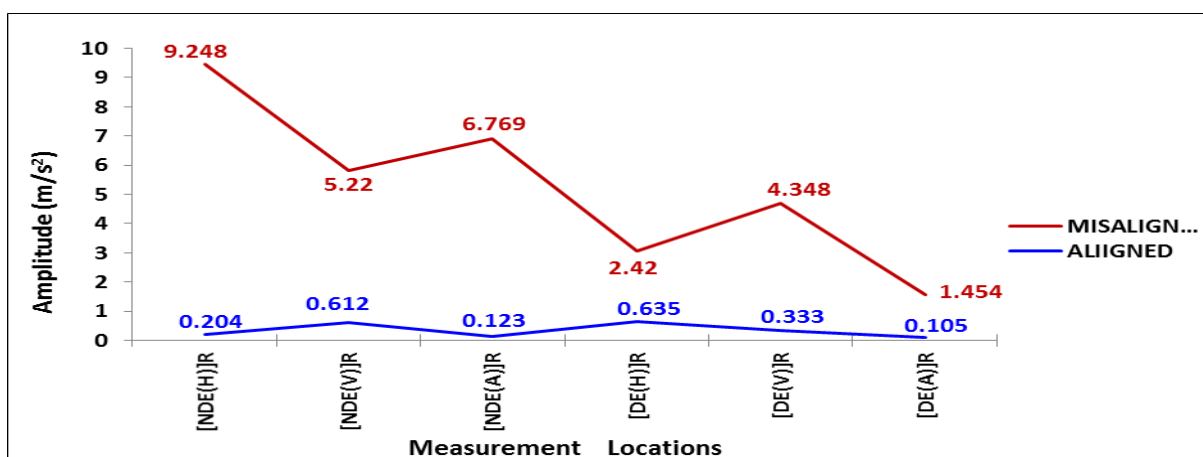
Fig. 9 Amplitude trends of NDE & DE of both motor and rotor in baseline and misaligned conditions with two rotors in INTERMEDIATE POSITION along ROTOR SIDE
